# Access Compliance Report

## Public Rights-of-Way

### (Curb Ramps)

Intersection ID: 19152	Main Street: E_INDEPENDENCE_BV	Cross Street: VILLAGE_LAKE_DR	Location:	N
ADA ID: 55CA76E25BE6	Ramp Type: PerpDiag	Initial Pass/Fail: Fail	Overall Compliance: No	Severity Score: 25
Codes/Mitigation Info/Possible Solution		Field Measurements/Component Compliance

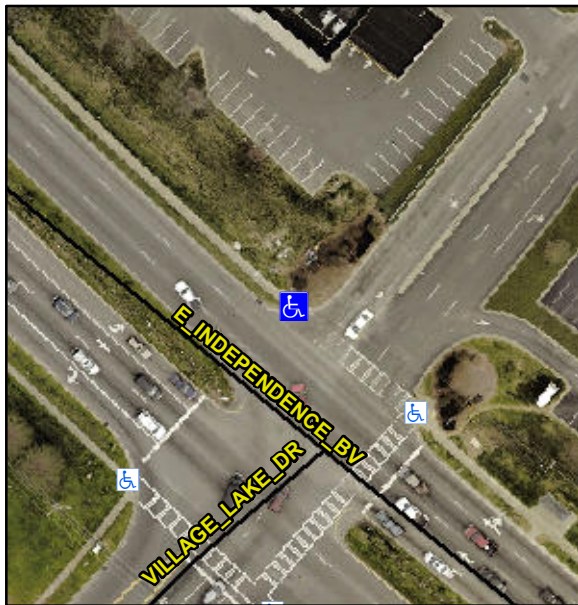
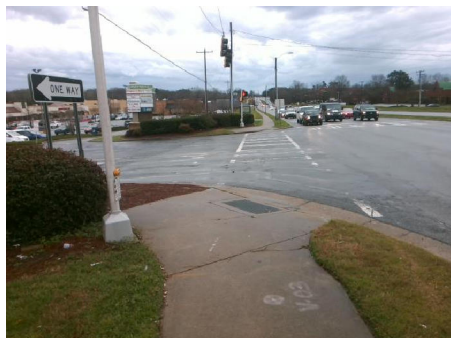
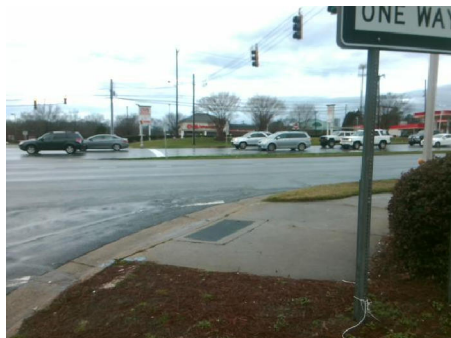
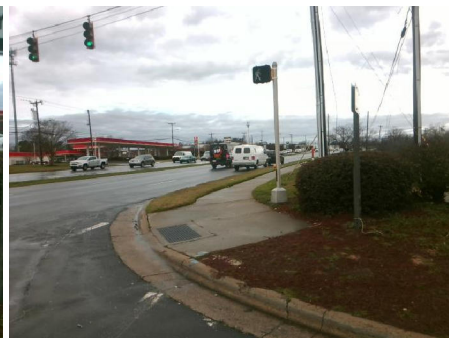
**Not Found, R304.5.3**

Compliance	Description	Data	Compliance	Description	Data
N/A	Ramp Length (in)	111.0	Yes	Ramp Slope (%)	6.5
Yes	Ramp Width (in)	51.0	No	Ramp XSlope (%)	7.5
N/A	Flare Type LT	N/A	N/A	Flare Type RT	N/A
N/A	Flare Slope LT (%)	N/A	N/A	Flare Slope RT (%)	N/A
N/A	Flare Traversable LT?	N/A	N/A	Flare Traversable RT?	N/A
N/A	Landing Length (in)	N/A	N/A	DWS Provided?	N/A
N/A	Landing Width (in)	N/A	N/A	DWS Contrast?	N/A
N/A	Landing Slope (%)	N/A	N/A	DWS Length (in)	N/A
N/A	Landing X Slope (%)	N/A	N/A	DWS Full Width?	N/A
N/A	Landing Curb? (Y/N)	N/A	N/A	DWS Offset (in)	N/A
N/A	Shared Landing?	N/A			
N/A	Gutter Ponding?	N/A	N/A	Gutter Slope (%)	N/A
N/A	Gutter Lip Ht (in)	N/A	N/A	Gutter X Slope (%)	N/A
N/A	Painted X Walk1?	No	N/A	Painted X Walk2?	Yes
	X Walk 1 Direction	To SW		X Walk 2 Direction	To SE
N/A	X Walk 1 Width (in)	N/A	N/A	X Walk 2 Width (in)	109.0
	X Walk 1 Slope (%)	3.8		X Walk 2 Slope (%)	4.9
	X Walk 1 X Slope (%)	1.8		X Walk 2 X Slope (%)	3.3

N/A	Ramp inside XWalk1?	N/A	N/A	Ramp inside XWalk2?	Yes
	Road Slope (%)	5.8	N/A	Clear Space?	N/A
	Road X Slope (%)	0.3	N/A	Clear Space to XWalk (in)	N/A
N/A	Any Obstructions?	N/A	N/A	Storm Grate/Utility Hazard?	N/A
	Obstruction Type			Storm Grate/Utility Type	
		N/A			N/A
		Yes		Surface Condition? (G/P)	Good

**Remove & Replace Curb Ramp With Two New Directional Ramps or Equivalent.**
