Access Compliance Report Public Rights-of-Way (Curb Ramps)

Intersection ID: 10032835 Main Street: NATIONS_FORD_RD Cross Street: N/A Location: SW Overall Compliance: No **Severity Score: ADA ID: 55DF7D2D438E** Ramp Type: Perp Initial Pass/Fail: Fail 12.5

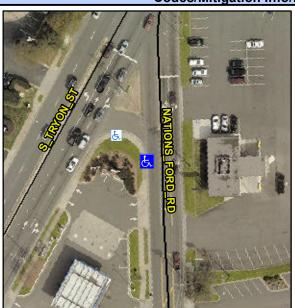
Field Measurements/Component Compliance							
Comp	liance Description	Data	Comp	liance Description	Data		
N/A	Ramp Length (in)	53.0	No	Ramp Slope (%)	10.5		
Yes	Ramp Width (in)	54.0	Yes	Ramp XSlope (%)	0.9		
N/A	Flare Type LT	N/A	N/A	Flare Type RT	N/A		
N/A	Flare Slope LT (%)	N/A	N/A	Flare Slope RT (%)	N/A		
N/A	Flare Traversable LT?	N/A	N/A	Flare Traversable RT?	N/A		
N/A	Landing Length (in)	N/A	N/A	DWS Provided?	N/A		
N/A	Landing Width (in)	N/A	N/A	DWS Contrast?	N/A		
N/A	Landing Slope (%)	N/A	N/A	DWS Length (in)	N/A		
N/A	Landing X Slope (%)	N/A	N/A	DWS Full Width?	N/A		
N/A	Landing Curb? (Y/N)	N/A	N/A	DWS Offset (in)	N/A		
N/A	Shared Landing?	N/A					
N/A	Gutter Ponding?	N/A	N/A	Gutter Slope (%)	N/A		
N/A	Gutter Lip Ht (in)	N/A	N/A	Gutter X Slope (%)	N/A		
N/A	Painted X Walk1?	No	N/A	Painted X Walk2?	N/A		
	X Walk 1 Direction	To E		X Walk 2 Direction	N/A		
N/A	X Walk 1 Width (in)	N/A	N/A	X Walk 2 Width (in)	N/A

X Walk 1 Slope (%)	1.9		X Walk 2 Slope (%)	N/A		
	X Walk 1 X Slope (%)	2.4		X Walk 2 X Slope (%)	N/A		
N/A	Ramp inside XWalk1?	N/A	N/A	Ramp inside XWalk2?	N/A		
	Road Slope (%)	N/A	N/A	Clear Space?	N/A		
	Road X Slope (%)	N/A	N/A	Clear Space to XWalk (in)	N/A		
N/A	Any Obstructions?	N/A	N/A	Storm Grate/Utility Hazard?	N/A		
	Obstruction Type			Storm Grate/Utility Type			
		N/A			N/A		
			Yes	Surface Condition? (G/P)	Good

Possible Solutions:	9
Remove & Replace Entire Ramp.	
	•
	ı
	I
	ı
	I
Surveyor Notes:	ı
N/A	ı
	ı
	I
	I
PROW/ADA:	I
Not Found, R304.2.2	ı
	I
	ı
	I
