Access Compliance Report

Public Rights-of-Way

(Curb Ramps)

Intersection ID: 52919	Main Street: HOOVER_CREEK_BV	Cross Street: WALKER_BRANCH_DR	Location: E
ADA ID: 55ECBF136A81	Ramp Type: PerpDiag	Initial Pass/Fail: Fail	Overall Compliance: No
Severity Score: 8.75			
Codes/Mitigation Info/Possible Solution		Field Measurements/Component Compliance

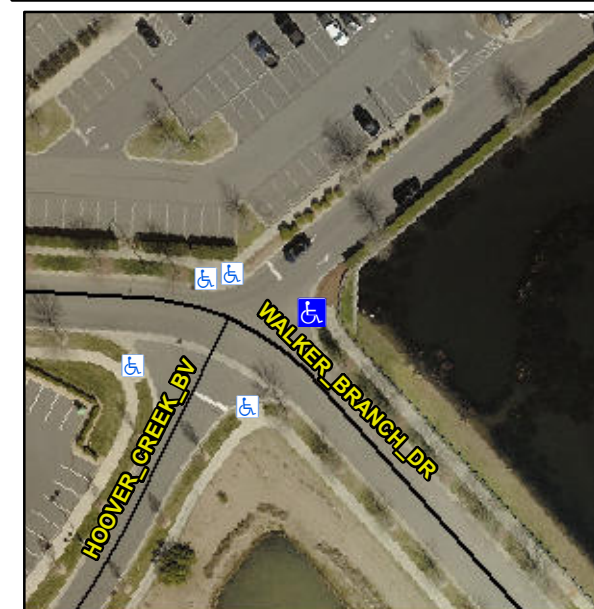
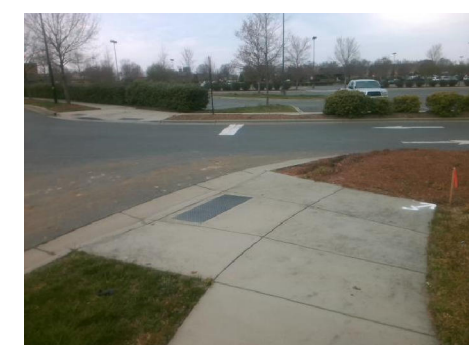
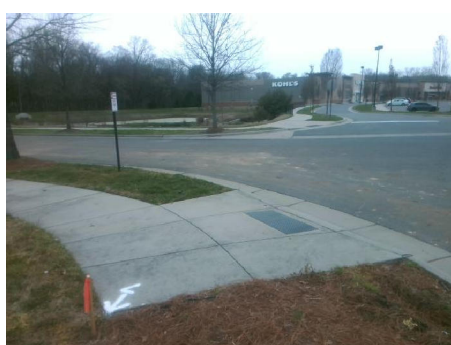
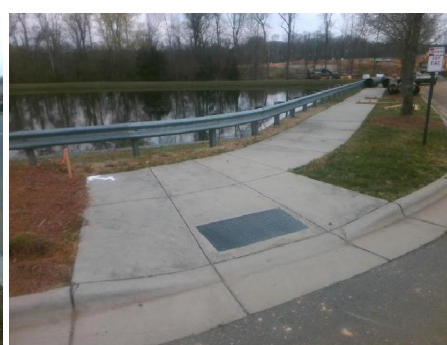
Not Found, R304.5.1

Compliance	Description	Data	Compliance	Description	Data
N/A	Ramp Length (in)	71.0	Yes	Ramp Slope (%)	5.8
No	Ramp Width (in)	46.5	Yes	Ramp XSlope (%)	0.9
N/A	Flare Type LT	N/A	N/A	Flare Type RT	N/A
N/A	Flare Slope LT (%)	N/A	N/A	Flare Slope RT (%)	N/A
N/A	Flare Traversable LT?	N/A	N/A	Flare Traversable RT?	N/A
N/A	Landing Length (in)	N/A	N/A	DWS Provided?	N/A
N/A	Landing Width (in)	N/A	N/A	DWS Contrast?	N/A
N/A	Landing Slope (%)	N/A	N/A	DWS Length (in)	N/A
N/A	Landing X Slope (%)	N/A	N/A	DWS Full Width?	N/A
N/A	Landing Curb? (Y/N)	N/A	N/A	DWS Offset (in)	N/A
N/A	Shared Landing?	N/A			
N/A	Gutter Ponding?	N/A	N/A	Gutter Slope (%)	N/A
N/A	Gutter Lip Ht (in)	N/A	N/A	Gutter X Slope (%)	N/A
N/A	Painted X Walk1?	No	N/A	Painted X Walk2?	No
	X Walk 1 Direction	To NW		X Walk 2 Direction	To SW
N/A	X Walk 1 Width (in)	N/A	N/A	X Walk 2 Width (in)	N/A
	X Walk 1 Slope (%)	2.1		X Walk 2 Slope (%)	0.0
	X Walk 1 X Slope (%)	2.7		X Walk 2 X Slope (%)	4.0

N/A	Ramp inside XWalk1?	N/A	N/A	Ramp inside XWalk2?	N/A
	Road Slope (%)	1.1	N/A	Clear Space?	N/A
	Road X Slope (%)	3.5	N/A	Clear Space to XWalk (in)	N/A
N/A	Any Obstructions?	N/A	N/A	Storm Grate/Utility Hazard?	N/A
	Obstruction Type			Storm Grate/Utility Type	
		N/A			N/A
			Yes	Surface Condition? (G/P)	Good

Remove & Replace Curb Ramp With Two New Directional Ramps or Equivalent.
