## Access Compliance Report Public Rights-of-Way (Curb Ramps)

Intersection ID: 10457 Main Street: GALWAY\_DR Cross Street: RUTH\_DR Location: SW

ADA ID: 55F029AD4B4C Ramp Type: BlendTrans2 Initial Pass/Fail: Fail Overall Compliance: No Severity Score: 12.5

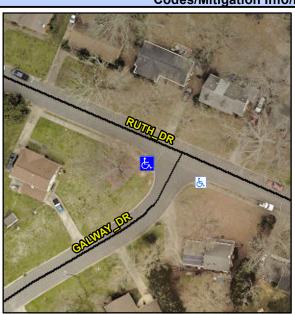
Not Found, R304.5.3

N/A	Ramp Length (in)	102.0	Yes	BlendTrans Slope (%)	4.9
Yes	Ramp Width (in)	60.0	No	BlendTrans XSlope (%)	5.2
N/A	Flare Type LT	N/A	N/A	Flare Type RT	N/A
N/A	Flare Slope LT (%)	N/A	N/A	Flare Slope RT (%)	N/A
N/A	Flare Traversable LT?	N/A	N/A	Flare Traversable RT?	N/A
N/A	Landing Length (in)	N/A	N/A	DWS Provided?	N/A
N/A	Landing Width (in)	N/A	N/A	DWS Contrast?	N/A
N/A	Landing Slope (%)	N/A	N/A	DWS Length (in)	N/A
N/A	Landing X Slope (%)	N/A	N/A	DWS Full Width?	N/A
N/A	Landing Curb? (Y/N)	N/A	N/A	DWS Offset (in)	N/A
N/A	Shared Landing?	N/A			
N/A	Gutter Ponding?	N/A	N/A	Gutter Slope (%)	N/A
N/A	Gutter Lip Ht (in)	2.0	N/A	Gutter X Slope (%)	N/A
N/A	Painted X Walk1?	No	N/A	Painted X Walk2?	N/A
	X Walk 1 Direction	To SE		X Walk 2 Direction	N/A
	X Walk 1 Width (in)	N/A		X Walk 2 Width (in)	N/A
	X Walk 1 Slope (%)	0.4		X Walk 2 Slope (%)	N/A
	X Walk 1 X Slope (%)	3.2		X Walk 2 X Slope (%)	N/A
N/A	Ramp inside XWalk1?	N/A	N/A	Ramp inside XWalk2?	N/A

Road Slope (%)	3.2		Clear Space?	N/A
	Road X Slope (%)	0.4	N/A	Clear Space to XWalk (in)	N/A
N/A	Any Obstructions?	N/A	N/A	Storm Grate/Utility Hazard?	N/A
	Obstruction Type		Į.	Storm Grate/Utility Type	
		N/A	l		N/A
			Yes	Surface Condition? (G/P)	Good
			No	Curb Slope (%)	23.7

Remove & Replace Curb Ramp With Two New Directional Ramps or Equivalent.
