Access Compliance Report

Public Rights-of-Way

(Curb Ramps)

Intersection ID: 51721	Main Street: PROVIDENCE_RD_WEST	Cross Street: BALLANCROFT_PY	Location: SW
ADA ID: 55F13A9847CD	Ramp Type: Perp	Initial Pass/Fail: Fail	Overall Compliance: No
Severity Score: 10			
Codes/Mitigation Info/Possible Solution		Field Measurements/Component Compliance

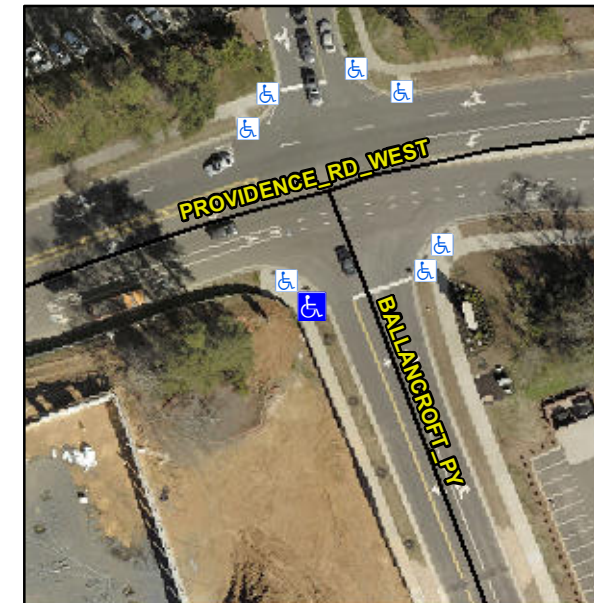
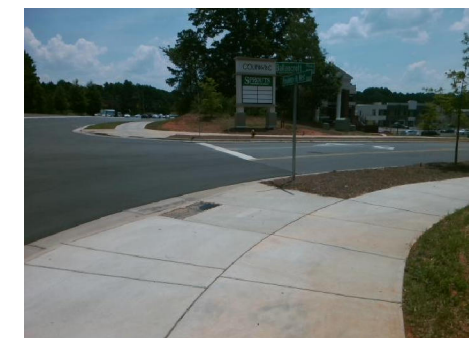
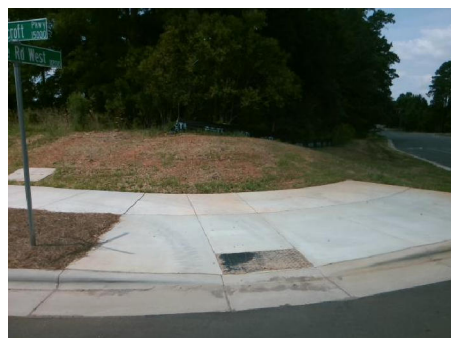
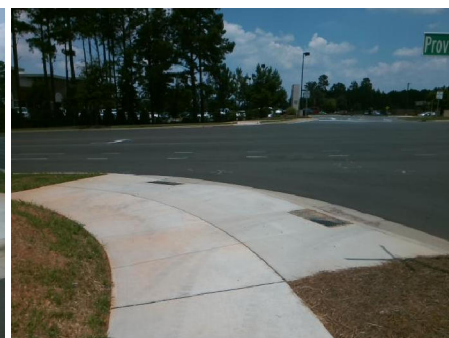
Not Found, R304.5.1, R304.5.3

Compliance	Description	Data	Compliance	Description	Data
N/A	Ramp Length (in)	96.0	Yes	Ramp Slope (%)	5.1
No	Ramp Width (in)	47.0	No	Ramp XSlope (%)	2.2
N/A	Flare Type LT	N/A	N/A	Flare Type RT	N/A
N/A	Flare Slope LT (%)	N/A	N/A	Flare Slope RT (%)	N/A
N/A	Flare Traversable LT?	N/A	N/A	Flare Traversable RT?	N/A
N/A	Landing Length (in)	N/A	N/A	DWS Provided?	N/A
N/A	Landing Width (in)	N/A	N/A	DWS Contrast?	N/A
N/A	Landing Slope (%)	N/A	N/A	DWS Length (in)	N/A
N/A	Landing X Slope (%)	N/A	N/A	DWS Full Width?	N/A
N/A	Landing Curb? (Y/N)	N/A	N/A	DWS Offset (in)	N/A
N/A	Shared Landing?	N/A			
N/A	Gutter Ponding?	N/A	N/A	Gutter Slope (%)	N/A
N/A	Gutter Lip Ht (in)	N/A	N/A	Gutter X Slope (%)	N/A
N/A	Painted X Walk1?	No	N/A	Painted X Walk2?	N/A
	X Walk 1 Direction	To E		X Walk 2 Direction	N/A
N/A	X Walk 1 Width (in)	N/A	N/A	X Walk 2 Width (in)	N/A
	X Walk 1 Slope (%)	2.2		X Walk 2 Slope (%)	N/A
	X Walk 1 X Slope (%)	1.4		X Walk 2 X Slope (%)	N/A

N/A	Ramp inside XWalk1?	N/A	N/A	Ramp inside XWalk2?	N/A
	Road Slope (%)	N/A	N/A	Clear Space?	N/A
	Road X Slope (%)	N/A	N/A	Clear Space to XWalk (in)	N/A
N/A	Any Obstructions?	N/A	N/A	Storm Grate/Utility Hazard?	N/A
	Obstruction Type			Storm Grate/Utility Type	
		N/A			N/A
			Yes	Surface Condition? (G/P)	Good

Remove & Replace Entire Ramp.

Total Cost: \$ 1850.00
