# Access Compliance Report

## Public Rights-of-Way

### (Curb Ramps)

Intersection ID: 5819	Main Street: HANBERRY_BV	Cross Street: ST_JOSEPH_DR	Location: SW
ADA ID: 55F57A750CDC	Ramp Type: PerpDiag	Initial Pass/Fail: Fail	Overall Compliance: No
Severity Score: 22.5			
Codes/Mitigation Info/Possible Solution		Field Measurements/Component Compliance

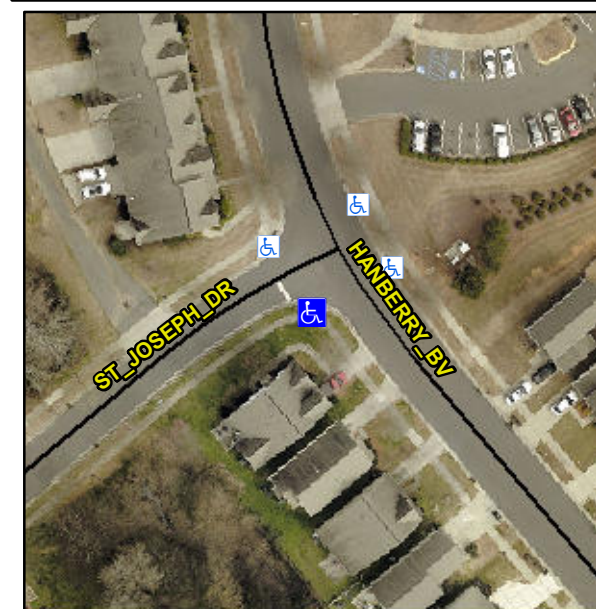
**Not Found, R304.5.1, R304.2.2, R304.5.3**

Compliance	Description	Data	Compliance	Description	Data
N/A	Ramp Length (in)	59.5	No	Ramp Slope (%)	10.1
No	Ramp Width (in)	46.5	No	Ramp XSlope (%)	3.8
N/A	Flare Type LT	N/A	N/A	Flare Type RT	N/A
N/A	Flare Slope LT (%)	N/A	N/A	Flare Slope RT (%)	N/A
N/A	Flare Traversable LT?	N/A	N/A	Flare Traversable RT?	N/A
N/A	Landing Length (in)	N/A	N/A	DWS Provided?	N/A
N/A	Landing Width (in)	N/A	N/A	DWS Contrast?	N/A
N/A	Landing Slope (%)	N/A	N/A	DWS Length (in)	N/A
N/A	Landing X Slope (%)	N/A	N/A	DWS Full Width?	N/A
N/A	Landing Curb? (Y/N)	N/A	N/A	DWS Offset (in)	N/A
N/A	Shared Landing?	N/A			
N/A	Gutter Ponding?	N/A	N/A	Gutter Slope (%)	N/A
N/A	Gutter Lip Ht (in)	N/A	N/A	Gutter X Slope (%)	N/A
N/A	Painted X Walk1?	No	N/A	Painted X Walk2?	No
	X Walk 1 Direction	To NE		X Walk 2 Direction	To NW
N/A	X Walk 1 Width (in)	N/A	N/A	X Walk 2 Width (in)	N/A
	X Walk 1 Slope (%)	2.4		X Walk 2 Slope (%)	2.8
	X Walk 1 X Slope (%)	0.7		X Walk 2 X Slope (%)	0.5

N/A	Ramp inside XWalk1?	N/A	N/A	Ramp inside XWalk2?	N/A
	Road Slope (%)	5.1	N/A	Clear Space?	N/A
	Road X Slope (%)	0.8	N/A	Clear Space to XWalk (in)	N/A
N/A	Any Obstructions?	N/A	N/A	Storm Grate/Utility Hazard?	N/A
	Obstruction Type			Storm Grate/Utility Type	
		N/A			N/A
			Yes	Surface Condition? (G/P)	Good

Possible Solutions:

**Remove & Replace Curb Ramp With Two New Directional Ramps or Equivalent.**
