# Access Compliance Report

## Public Rights-of-Way

### (Curb Ramps)

Intersection ID: 10036434	Main Street: ROXBOROUGH_RD	Cross Street: N/A	Location: NW
ADA ID: 55F7D91208F2	Ramp Type: PerpDiag	Initial Pass/Fail: Fail	Overall Compliance: No
		Severity Score: 12.5

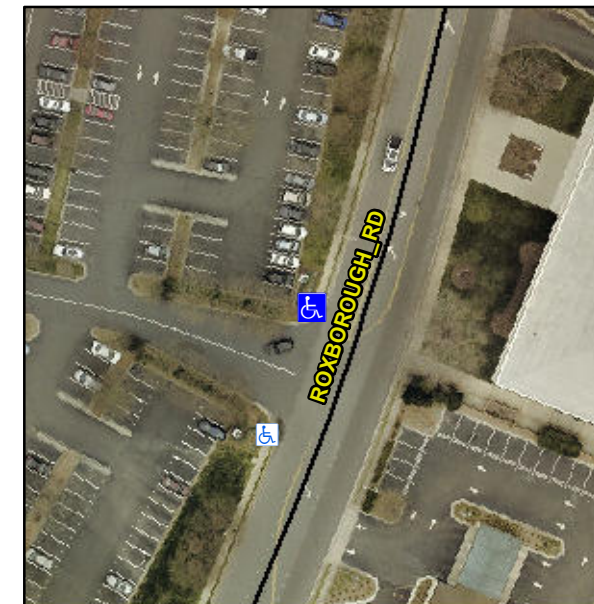
**Not Found, R304.2.2**

Compliance	Description	Data	Compliance	Description	Data
N/A	Ramp Length (in)	43.0	No	Ramp Slope (%)	8.7
Yes	Ramp Width (in)	48.0	Yes	Ramp XSlope (%)	1.6
N/A	Flare Type LT	N/A	N/A	Flare Type RT	N/A
N/A	Flare Slope LT (%)	N/A	N/A	Flare Slope RT (%)	N/A
N/A	Flare Traversable LT?	N/A	N/A	Flare Traversable RT?	N/A
N/A	Landing Length (in)	N/A	N/A	DWS Provided?	N/A
N/A	Landing Width (in)	N/A	N/A	DWS Contrast?	N/A
N/A	Landing Slope (%)	N/A	N/A	DWS Length (in)	N/A
N/A	Landing X Slope (%)	N/A	N/A	DWS Full Width?	N/A
N/A	Landing Curb? (Y/N)	N/A	N/A	DWS Offset (in)	N/A
N/A	Shared Landing?	N/A			
N/A	Gutter Ponding?	N/A	N/A	Gutter Slope (%)	N/A
N/A	Gutter Lip Ht (in)	N/A	N/A	Gutter X Slope (%)	N/A
N/A	Painted X Walk1?	No	N/A	Painted X Walk2?	No
	X Walk 1 Direction	To S		X Walk 2 Direction	To E
N/A	X Walk 1 Width (in)	N/A	N/A	X Walk 2 Width (in)	N/A
	X Walk 1 Slope (%)	4.0		X Walk 2 Slope (%)	6.3
	X Walk 1 X Slope (%)	5.3		X Walk 2 X Slope (%)	2.4

N/A	Ramp inside XWalk1?	N/A	N/A	Ramp inside XWalk2?	N/A
	Road Slope (%)	2.0	N/A	Clear Space?	N/A
	Road X Slope (%)	12.2	N/A	Clear Space to XWalk (in)	N/A
N/A	Any Obstructions?	N/A	N/A	Storm Grate/Utility Hazard?	N/A
	Obstruction Type			Storm Grate/Utility Type	
		N/A			N/A
			Yes	Surface Condition? (G/P)	Good

**Remove & Replace Curb Ramp With Two New Directional Ramps or Equivalent.**
