Access Compliance Report

Public Rights-of-Way

(Curb Ramps)

Intersection ID: 28936	Main Street: CHRISTENBURY_RD	Cross Street: BRANDIE_GLEN_RD	Location: NE
ADA ID: 55FA4B859BAD	Ramp Type: Perp	Initial Pass/Fail: Fail	Overall Compliance: No
			Severity Score: 21.25

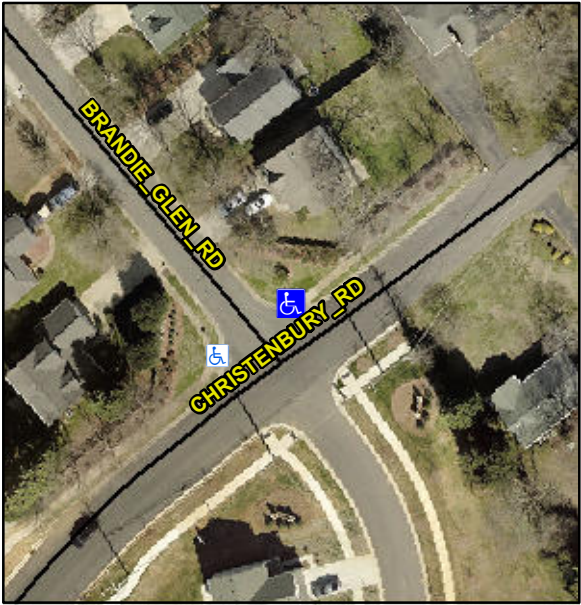
Possible Solutions:		Compliance	Description	Data
	Remove & Replace Entire Ramp.		N/A	Ramp Length (in)	70.0
			No	Ramp Width (in)	40.0
			N/A	Flare Type LT	N/A
			N/A	Flare Slope LT (%)	N/A
			N/A	Flare Traversable LT?	N/A
			N/A	Landing Length (in)	N/A
			N/A	Landing Width (in)	N/A
			N/A	Landing Slope (%)	N/A
			N/A	Landing X Slope (%)	N/A
<p>Surveyor Notes:</p> <p>N/A</p> <p>PROW/ADA:</p> <p>Not Found, R304.5.1, R304.2.2</p>			N/A	Flare Type RT	N/A
			N/A	Flare Slope RT (%)	N/A
			N/A	Flare Traversable RT?	N/A
			N/A	DWS Provided?	N/A
			N/A	DWS Contrast?	N/A
			N/A	DWS Length (in)	N/A
			N/A	DWS Full Width?	N/A
			N/A	DWS Offset (in)	N/A
			N/A	Shared Landing?	N/A
			N/A	Gutter Ponding?	N/A
			N/A	Gutter Lip Ht (in)	N/A
			N/A	Painted X Walk1?	No
				X Walk 1 Direction	To SW
			N/A	X Walk 1 Width (in)	N/A
				X Walk 1 Slope (%)	1.0

X Walk 1 X Slope (%)	1.6
			N/A	Ramp inside XWalk1?	N/A
			N/A	Road Slope (%)	N/A
			N/A	Road X Slope (%)	N/A
			N/A	Any Obstructions?	N/A
				Obstruction Type	
Total Cost:		\$ 1850.00			
			N/A		N/A
			Yes	Surface Condition? (G/P)	Good
