Access Compliance Report

Public Rights-of-Way

(Curb Ramps)

Intersection ID: 42506	Main Street: CHASEWATER_DR	Cross Street: DARBY_CHASE_DR	Location: SE
ADA ID: 55FAA7BE2EBB	Ramp Type: Perp	Initial Pass/Fail: Fail	Overall Compliance: No
			Severity Score: 18.75

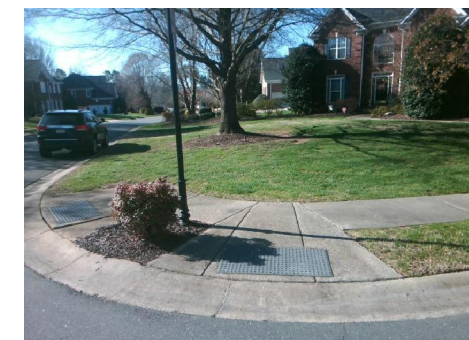
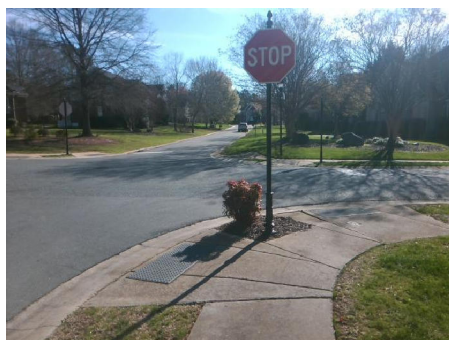
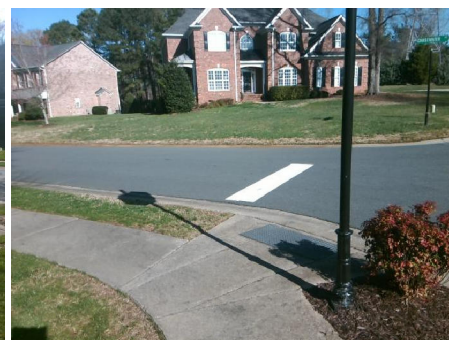
Not Found, R304.5.1, R304.5.3

Compliance	Description	Data	Compliance	Description	Data
N/A	Ramp Length (in)	48.0	Yes	Ramp Slope (%)	6.1
No	Ramp Width (in)	35.0	No	Ramp XSlope (%)	2.8
N/A	Flare Type LT	N/A	N/A	Flare Type RT	N/A
N/A	Flare Slope LT (%)	N/A	N/A	Flare Slope RT (%)	N/A
N/A	Flare Traversable LT?	N/A	N/A	Flare Traversable RT?	N/A
N/A	Landing Length (in)	N/A	N/A	DWS Provided?	N/A
N/A	Landing Width (in)	N/A	N/A	DWS Contrast?	N/A
N/A	Landing Slope (%)	N/A	N/A	DWS Length (in)	N/A
N/A	Landing X Slope (%)	N/A	N/A	DWS Full Width?	N/A
N/A	Landing Curb? (Y/N)	N/A	N/A	DWS Offset (in)	N/A
N/A	Shared Landing?	N/A			
N/A	Gutter Ponding?	N/A	N/A	Gutter Slope (%)	N/A
N/A	Gutter Lip Ht (in)	N/A	N/A	Gutter X Slope (%)	N/A
N/A	Painted X Walk1?	No	N/A	Painted X Walk2?	N/A
	X Walk 1 Direction	To N		X Walk 2 Direction	N/A
N/A	X Walk 1 Width (in)	N/A	N/A	X Walk 2 Width (in)	N/A
	X Walk 1 Slope (%)	1.6		X Walk 2 Slope (%)	N/A
	X Walk 1 X Slope (%)	4.2		X Walk 2 X Slope (%)	N/A

Remove & Replace Entire Ramp.
