Access Compliance Report

Public Rights-of-Way

(Curb Ramps)

Intersection ID: 17896	Main Street: BELROSE_LN	Cross Street: SCALEYBARK_RD	Location: NE
ADA ID: 560055C0A3C7	Ramp Type: Para	Initial Pass/Fail: Fail	Overall Compliance: No
Severity Score: 1.25			
Codes/Mitigation Info/Possible Solution		Field Measurements/Component Compliance

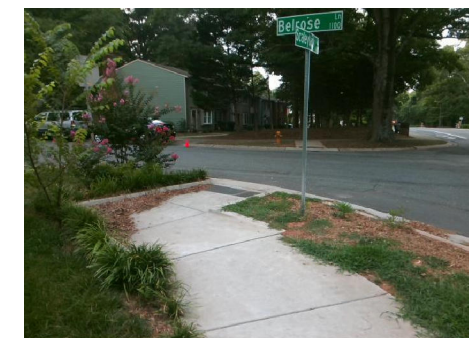
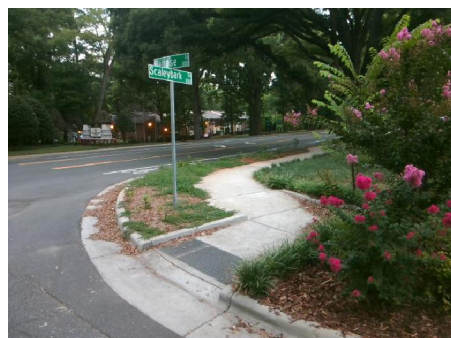
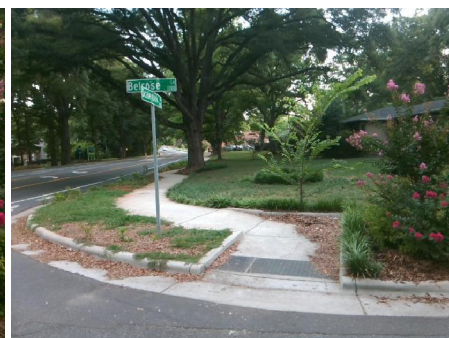
Compliance	Description	Data	Compliance	Description	Data
N/A	Ramp Length LT (in)	53.0	N/A	Ramp Length RT (in)	N/A
Yes	Ramp Width LT (in)	67.0	N/A	Ramp Width RT (in)	N/A
Yes	Ramp Slope LT (%)	5.7	N/A	Ramp Slope RT (%)	N/A
No	Ramp XSlope LT (%)	2.8	N/A	Ramp XSlope RT (%)	N/A
N/A	Landing Length (in)	N/A	N/A	DWS Provided?	N/A
N/A	Landing Width (in)	N/A	N/A	DWS Contrast?	N/A
N/A	Landing Slope (%)	N/A	N/A	DWS Length (in)	N/A
N/A	Landing X Slope (%)	N/A	N/A	DWS Full Width?	N/A
N/A	Landing Curb? (Y/N)	N/A	N/A	DWS Offset (in)	N/A
N/A	Shared Landing?	N/A			
N/A	Gutter Ponding?	N/A	N/A	Gutter Slope (%)	N/A
N/A	Gutter Lip Ht (in)	N/A	N/A	Gutter X Slope (%)	N/A
N/A	Painted X Walk1?	No	N/A	Painted X Walk2?	N/A
	X Walk 1 Direction	To SW		X Walk 2 Direction	N/A
N/A	X Walk 1 Width (in)	N/A	N/A	X Walk 2 Width (in)	N/A
	X Walk 1 Slope (%)	3.8		X Walk 2 Slope (%)	N/A
	X Walk 1 X Slope (%)	1.8		X Walk 2 X Slope (%)	N/A
N/A	Ramp inside XWalk1?	N/A	N/A	Ramp inside XWalk2?	N/A

Road Slope (%)	N/A	N/A	Clear Space?	N/A
	Road X Slope (%)	N/A	N/A	Clear Space to XWalk (in)	N/A
N/A	Any Obstructions?	N/A	N/A	Storm Grate/Utility Hazard?	N/A
	Obstruction Type			Storm Grate/Utility Type	
		N/A			N/A
			Yes	Surface Condition? (G/P)	Good
			N/A	Curb Slope (%)	15.9

Possible Solutions:

Remove & Replace Entire Ramp.

R304.5.3
