Access Compliance Report

Public Rights-of-Way

(Curb Ramps)

Intersection ID: 20146	Main Street: FAIRVIEW_RD	Cross Street: PARK_SOUTH_DR	Location: NW
ADA ID: 5607E8846A79	Ramp Type: Para	Initial Pass/Fail: Pass	Overall Compliance: No Severity Score: 0.25

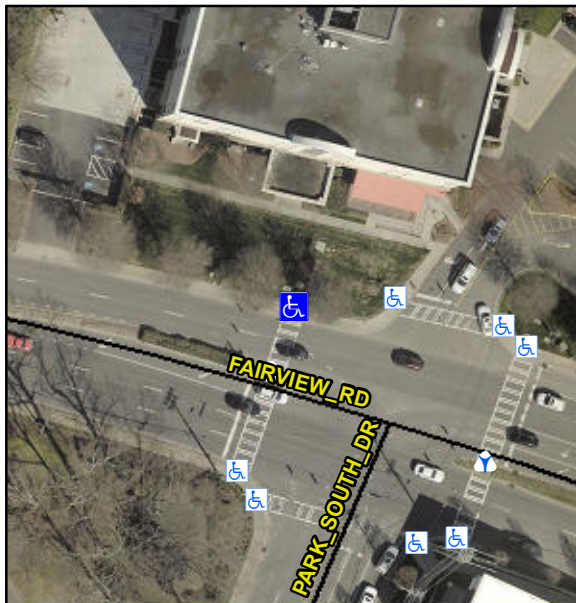
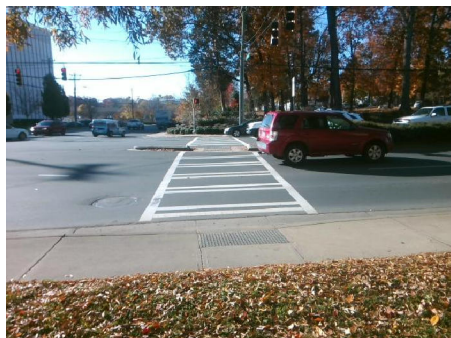
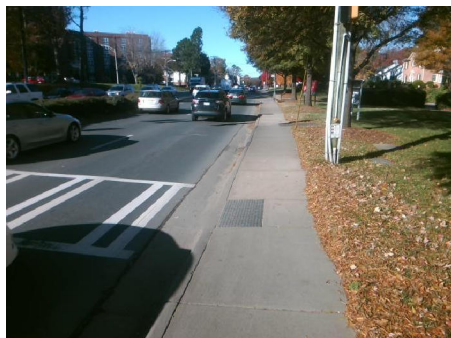
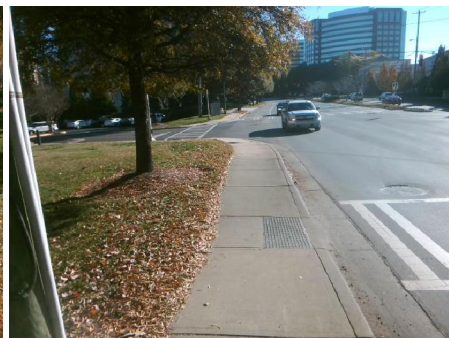
R304.5.3

Compliance	Description	Data	Compliance	Description	Data
N/A	Ramp Length LT (in)	72.0	N/A	Ramp Length RT (in)	72.0
Yes	Ramp Width LT (in)	60.0	Yes	Ramp Width RT (in)	60.0
Yes	Ramp Slope LT (%)	5.9	Yes	Ramp Slope RT (%)	5.6
No	Ramp XSlope LT (%)	3.5	Yes	Ramp XSlope RT (%)	1.7
Yes	Landing Length (in)	65.0	Yes	DWS Provided?	Yes
Yes	Landing Width (in)	48.0	Yes	DWS Contrast?	Yes
Yes	Landing Slope (%)	2.0	Yes	DWS Length (in)	25.0
Yes	Landing X Slope (%)	0.8	Yes	DWS Full Width?	Yes
N/A	Landing Curb? (Y/N)	No	Yes	DWS Offset (in)	0.0
N/A	Shared Landing?	No			
Yes	Gutter Ponding?	No	Yes	Gutter Slope (%)	0.6
Yes	Gutter Lip Ht (in)	0.0	Yes	Gutter X Slope (%)	0.0
N/A	Painted X Walk1?	Yes	N/A	Painted X Walk2?	N/A
	X Walk 1 Direction	To SW		X Walk 2 Direction	N/A
N/A	X Walk 1 Width (in)	108.0	N/A	X Walk 2 Width (in)	N/A
	X Walk 1 Slope (%)	3.7		X Walk 2 Slope (%)	N/A
	X Walk 1 X Slope (%)	0.4		X Walk 2 X Slope (%)	N/A
Yes	Ramp inside XWalk1?	Yes	N/A	Ramp inside XWalk2?	N/A

Road Slope (%)	N/A	N/A	Clear Space?	Yes
	Road X Slope (%)	N/A	N/A	Clear Space to XWalk (in)	N/A
Yes	Any Obstructions?	No	Yes	Storm Grate/Utility Hazard?	No
	Obstruction Type			Storm Grate/Utility Type	
		N/A			N/A
			Yes	Surface Condition? (G/P)	Good
			N/A	Curb Slope (%)	0.7

Remove & Replace Entire Ramp.
