# Access Compliance Report

## Public Rights-of-Way

### (Curb Ramps)

Intersection ID: 14576	Main Street: COMMONWEALTH_AV	Cross Street: PINECREST_AV	Location: E
ADA ID: 5609B15A6747	Ramp Type: Perp	Initial Pass/Fail: Fail	Overall Compliance: No
Severity Score: 8.75			
Codes/Mitigation Info/Possible Solution		Field Measurements/Component Compliance

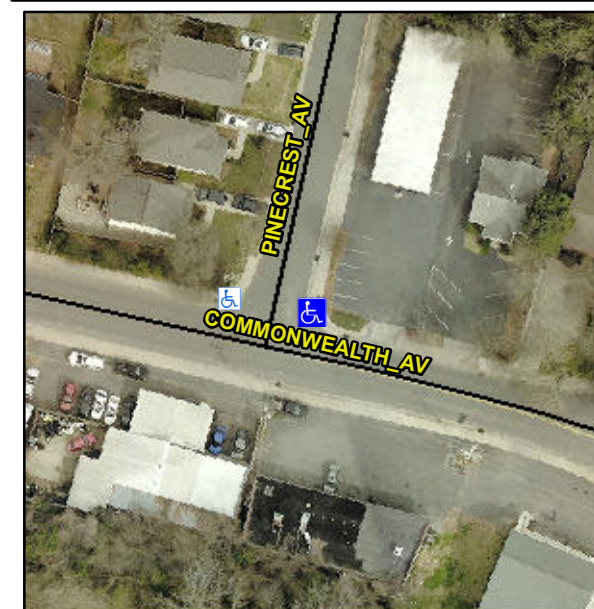
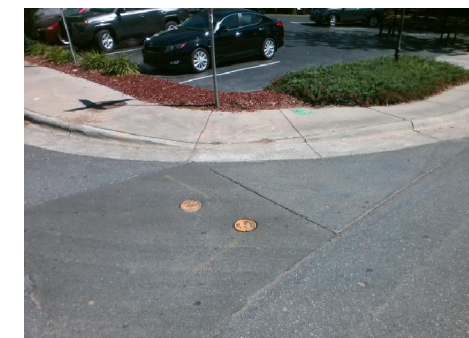
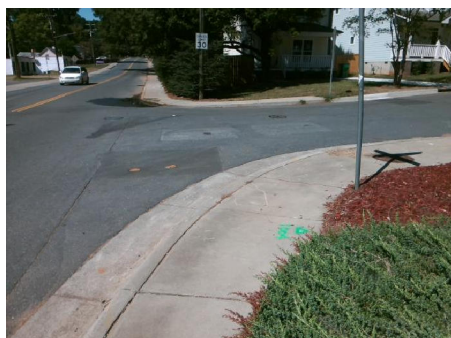
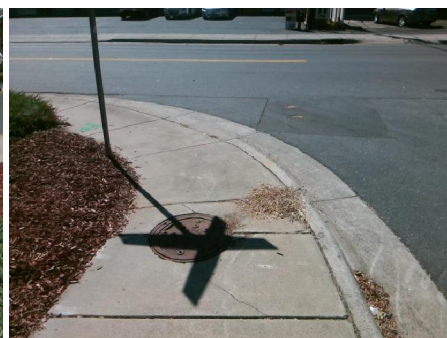
Compliance	Description	Data	Compliance	Description	Data
N/A	Ramp Length (in)	60.0	Yes	Ramp Slope (%)	8.3
No	Ramp Width (in)	46.5	Yes	Ramp XSlope (%)	1.1
N/A	Flare Type LT	N/A	N/A	Flare Type RT	N/A
N/A	Flare Slope LT (%)	N/A	N/A	Flare Slope RT (%)	N/A
N/A	Flare Traversable LT?	N/A	N/A	Flare Traversable RT?	N/A
N/A	Landing Length (in)	N/A	N/A	DWS Provided?	N/A
N/A	Landing Width (in)	N/A	N/A	DWS Contrast?	N/A
N/A	Landing Slope (%)	N/A	N/A	DWS Length (in)	N/A
N/A	Landing X Slope (%)	N/A	N/A	DWS Full Width?	N/A
N/A	Landing Curb? (Y/N)	N/A	N/A	DWS Offset (in)	N/A
N/A	Shared Landing?	N/A			
N/A	Gutter Ponding?	N/A	N/A	Gutter Slope (%)	N/A
N/A	Gutter Lip Ht (in)	N/A	N/A	Gutter X Slope (%)	N/A
N/A	Painted X Walk1?	No	N/A	Painted X Walk2?	N/A
	X Walk 1 Direction	To NW		X Walk 2 Direction	N/A
N/A	X Walk 1 Width (in)	N/A	N/A	X Walk 2 Width (in)	N/A
	X Walk 1 Slope (%)	0.1		X Walk 2 Slope (%)	N/A
	X Walk 1 X Slope (%)	3.9		X Walk 2 X Slope (%)	N/A

N/A	Ramp inside XWalk1?	N/A	N/A	Ramp inside XWalk2?	N/A
	Road Slope (%)	N/A	N/A	Clear Space?	N/A
	Road X Slope (%)	N/A	N/A	Clear Space to XWalk (in)	N/A
N/A	Any Obstructions?	N/A	N/A	Storm Grate/Utility Hazard?	N/A
	Obstruction Type			Storm Grate/Utility Type	
		N/A			N/A
		Yes		Surface Condition? (G/P)	Good

**Remove & Replace Entire Ramp.**

**Not Found, R304.5.1**
