# Access Compliance Report

## Public Rights-of-Way

### (Curb Ramps)

Intersection ID: 8186	Main Street: CINDERELLA_RD	Cross Street: YUMA_ST	Location: E
ADA ID: 560BC2646B47	Ramp Type: Directional1	Initial Pass/Fail: Fail	Overall Compliance: No
Codes/Mitigation Info/Possible Solution		Field Measurements/Component Compliance	
Severity Score: 33.75

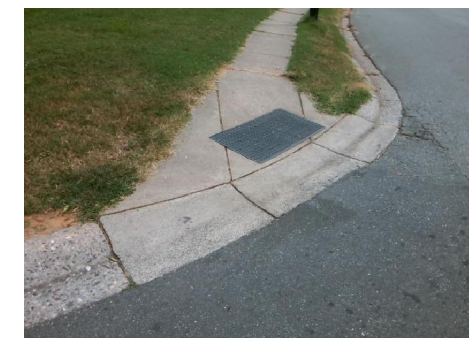
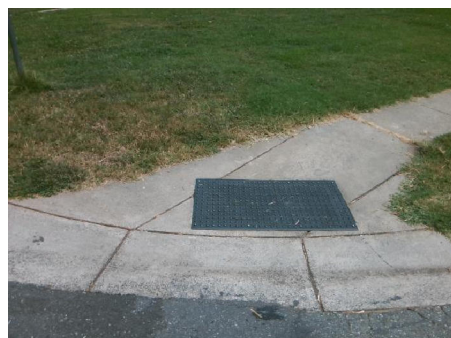
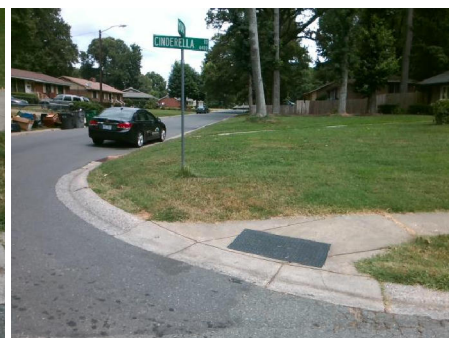
Compliance	Description	Data	Compliance	Description	Data
N/A	Ramp Length (in)	72.0	N/A	Grade Break?	N/A
No	Ramp Width (in)	42.0	N/A	Grade Break Slope (%)	0.0
Yes	Ramp Slope (%)	8.2	N/A	Grade Break XSlope (%)	0.0
No	Ramp XSlope (%)	10.3			
N/A	Flare Type LT	N/A	N/A	Flare Type RT	N/A
N/A	Flare Slope LT (%)	N/A	N/A	Flare Slope RT (%)	0.0
N/A	Flare Traversable LT?	N/A	N/A	Flare Traversable RT?	N/A
N/A	Landing Length (in)	0.0	N/A	DWS Provided?	N/A
N/A	Landing Width (in)	0.0	N/A	DWS Contrast?	N/A
N/A	Landing Slope (%)	0.0	N/A	DWS Length (in)	N/A
N/A	Landing X Slope (%)	0.0	N/A	DWS Full Width?	N/A
N/A	Landing Curb? (Y/N)	N/A	N/A	DWS Offset LT (in)	N/A
N/A	Shared Landing?	N/A	N/A	DWS Offset RT (in)	N/A
N/A	Gutter Ponding?	0.0	N/A	Gutter Slope (%)	N/A
N/A	Gutter Lip Ht (in)	0.0	N/A	Gutter X Slope (%)	N/A
N/A	Painted X Walk1?	No		Road Slope (%)	6.5
	X Walk 1 Direction	To NW		Road X Slope (%)	1.4
	X Walk 1 Width (in)	N/A		Clear Space?	N/A

X Walk 1 Slope (%)	6.5	N/A	Clear Space to XWalk (in)	N/A
	X Walk 1 X Slope (%)	1.4	N/A	Storm Grate/Utility Hazard?	N/A
N/A	Ramp inside XWalk1?	N/A		Storm Grate/Utility Type	
N/A	Any Obstructions?	N/A			N/A
	Obstruction Type		Yes	Surface Condition? (G/P)	Good
			N/A	Curb Slope (%)	13.8

**Remove & Replace Entire Ramp.**

**R304.5.1, R304.5.3**

\$ 1600.00
