Access Compliance Report

Public Rights-of-Way

(Curb Ramps)

Intersection ID: 4775	Main Street: OLD_STATESVILLE_RD	Cross Street: HENDERSON_CR	Location: E
ADA ID: 560CECBF5527	Ramp Type: Perp	Initial Pass/Fail: Fail	Overall Compliance: No
			Severity Score: 21.25

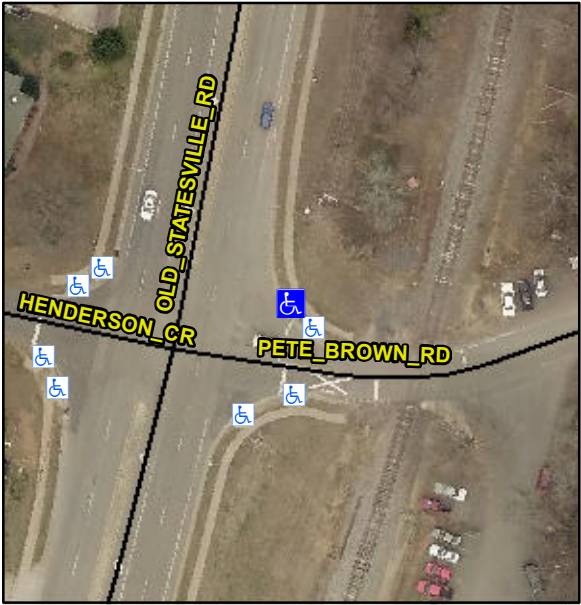
Possible Solutions:		Compliance	Description	Data
	Remove & Replace Entire Ramp.		Yes	Ramp Length (in)	59.0
			No	Ramp Width (in)	46.0
			N/A	Flare Type LT	N/A
			N/A	Flare Slope LT (%)	N/A
			N/A	Flare Traversable LT?	N/A
			N/A	Landing Length (in)	N/A
			N/A	Landing Width (in)	N/A
			N/A	Landing Slope (%)	N/A
			N/A	Landing X Slope (%)	N/A
<p>Surveyor Notes:</p> <p>N/A</p> <p>PROW/ADA:</p> <p>Not Found, R304.5.1, R304.5.3</p>			N/A	Flare Type RT	N/A
			N/A	Flare Slope RT (%)	N/A
			N/A	Flare Traversable RT?	N/A
			N/A	DWS Provided?	N/A
			N/A	DWS Contrast?	N/A
			N/A	DWS Length (in)	N/A
			N/A	DWS Full Width?	N/A
			N/A	DWS Offset (in)	N/A
			N/A	Shared Landing?	N/A
			N/A	Gutter Ponding?	N/A
			N/A	Gutter Lip Ht (in)	N/A
			N/A	Painted X Walk1?	No
				X Walk 1 Direction	To NW
			N/A	X Walk 1 Width (in)	N/A
				X Walk 1 Slope (%)	3.1

X Walk 1 X Slope (%)	5.5
			N/A	Ramp inside XWalk1?	N/A
			N/A	Road Slope (%)	N/A
			N/A	Road X Slope (%)	N/A
			N/A	Any Obstructions?	N/A
				Obstruction Type	
			N/A		
			N/A		
			N/A		
			N/A		
			N/A		
			N/A		
			N/A		
			N/A		
			N/A		
Total Cost:		\$ 1850.00			
			N/A		
			Yes	Surface Condition? (G/P)	Good
