Access Compliance Report

Public Rights-of-Way

(Curb Ramps)

Intersection ID: 13714	Main Street: HANOVER_ST	Cross Street: MCCLINTOCK_RD	Location: NW
ADA ID: 561019C2A5BB	Ramp Type: Perp	Initial Pass/Fail: Fail	Overall Compliance: No
Codes/Mitigation Info/Possible Solution			Severity Score: 10
			Field Measurements/Component Compliance

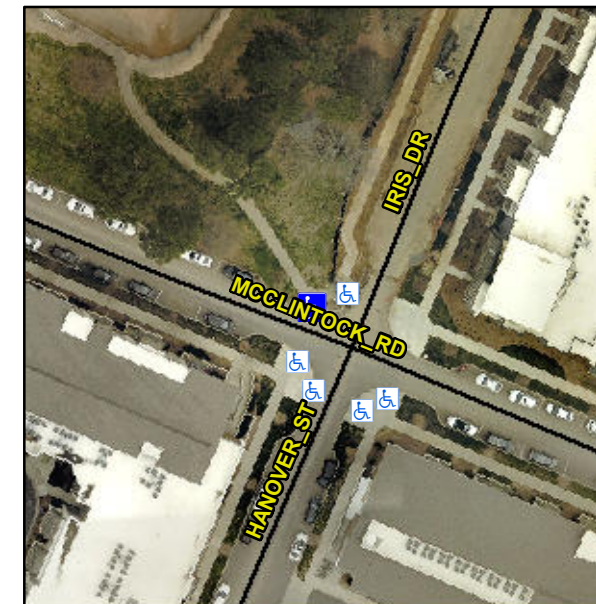
Compliance	Description	Data	Compliance	Description	Data
N/A	Ramp Length (in)	72.0	Yes	Ramp Slope (%)	6.9
No	Ramp Width (in)	47.0	No	Ramp XSlope (%)	3.3
N/A	Flare Type LT	N/A	N/A	Flare Type RT	N/A
N/A	Flare Slope LT (%)	N/A	N/A	Flare Slope RT (%)	N/A
N/A	Flare Traversable LT?	N/A	N/A	Flare Traversable RT?	N/A
N/A	Landing Length (in)	N/A	N/A	DWS Provided?	N/A
N/A	Landing Width (in)	N/A	N/A	DWS Contrast?	N/A
N/A	Landing Slope (%)	N/A	N/A	DWS Length (in)	N/A
N/A	Landing X Slope (%)	N/A	N/A	DWS Full Width?	N/A
N/A	Landing Curb? (Y/N)	N/A	N/A	DWS Offset (in)	N/A
N/A	Shared Landing?	N/A			
N/A	Gutter Ponding?	N/A	N/A	Gutter Slope (%)	N/A
N/A	Gutter Lip Ht (in)	N/A	N/A	Gutter X Slope (%)	N/A
N/A	Painted X Walk1?	No	N/A	Painted X Walk2?	N/A
	X Walk 1 Direction	To S		X Walk 2 Direction	N/A
N/A	X Walk 1 Width (in)	N/A	N/A	X Walk 2 Width (in)	N/A
	X Walk 1 Slope (%)	2.1		X Walk 2 Slope (%)	N/A
	X Walk 1 X Slope (%)	3.2		X Walk 2 X Slope (%)	N/A

N/A	Ramp inside XWalk1?	N/A	N/A	Ramp inside XWalk2?	N/A
	Road Slope (%)	N/A	N/A	Clear Space?	N/A
	Road X Slope (%)	N/A	N/A	Clear Space to XWalk (in)	N/A
N/A	Any Obstructions?	N/A	N/A	Storm Grate/Utility Hazard?	N/A
	Obstruction Type			Storm Grate/Utility Type	
		N/A			N/A
			Yes	Surface Condition? (G/P)	Good

Possible Solutions:

Remove & Replace Entire Ramp.
