Access Compliance Report

Public Rights-of-Way

(Curb Ramps)

Intersection ID: 10038086	Main Street: SIKES_PL	Cross Street: N/A	Location: NW
ADA ID: 5620A2618575	Ramp Type: PerpDiag	Initial Pass/Fail: Fail	Overall Compliance: No
Severity Score: 22.5			
Codes/Mitigation Info/Possible Solution		Field Measurements/Component Compliance

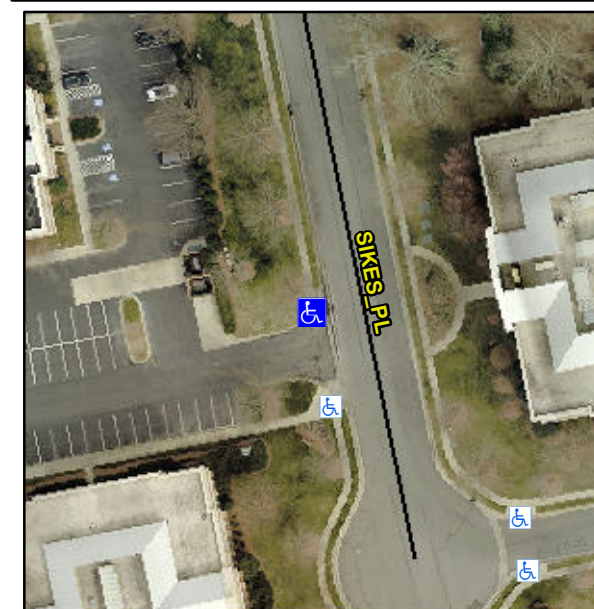
R304.5.1, R304.2.2, R304.5.3

Compliance	Description	Data	Compliance	Description	Data
N/A	Ramp Length (in)	46.0	No	Ramp Slope (%)	8.5
No	Ramp Width (in)	46.3	No	Ramp XSlope (%)	3.8
N/A	Flare Type LT	N/A	N/A	Flare Type RT	N/A
N/A	Flare Slope LT (%)	N/A	N/A	Flare Slope RT (%)	N/A
N/A	Flare Traversable LT?	N/A	N/A	Flare Traversable RT?	N/A
N/A	Landing Length (in)	N/A	N/A	DWS Provided?	N/A
N/A	Landing Width (in)	N/A	N/A	DWS Contrast?	N/A
N/A	Landing Slope (%)	N/A	N/A	DWS Length (in)	N/A
N/A	Landing X Slope (%)	N/A	N/A	DWS Full Width?	N/A
N/A	Landing Curb? (Y/N)	N/A	N/A	DWS Offset (in)	N/A
N/A	Shared Landing?	N/A			
N/A	Gutter Ponding?	N/A	N/A	Gutter Slope (%)	N/A
N/A	Gutter Lip Ht (in)	N/A	N/A	Gutter X Slope (%)	N/A
N/A	Painted X Walk1?	No	N/A	Painted X Walk2?	No
	X Walk 1 Direction	To S		X Walk 2 Direction	To E
N/A	X Walk 1 Width (in)	N/A	N/A	X Walk 2 Width (in)	N/A
	X Walk 1 Slope (%)	1.2		X Walk 2 Slope (%)	4.1
	X Walk 1 X Slope (%)	3.1		X Walk 2 X Slope (%)	1.1

N/A	Ramp inside XWalk1?	N/A	N/A	Ramp inside XWalk2?	N/A
	Road Slope (%)	3.8	N/A	Clear Space?	N/A
	Road X Slope (%)	5.7	N/A	Clear Space to XWalk (in)	N/A
N/A	Any Obstructions?	N/A	N/A	Storm Grate/Utility Hazard?	N/A
	Obstruction Type			Storm Grate/Utility Type	
		N/A			N/A
			Yes	Surface Condition? (G/P)	Good

Remove & Replace Curb Ramp With Two New Directional Ramps or Equivalent.
