# Access Compliance Report

## Public Rights-of-Way

Intersection ID: 10071	Main Street: E_36TH_ST	Cross Street: YADKIN_AV	Location: S
ADA ID: 56389B0514FA	Ramp Type: PerpDiag	Initial Pass/Fail: Fail	Overall Compliance: No
			Severity Score: 33.75

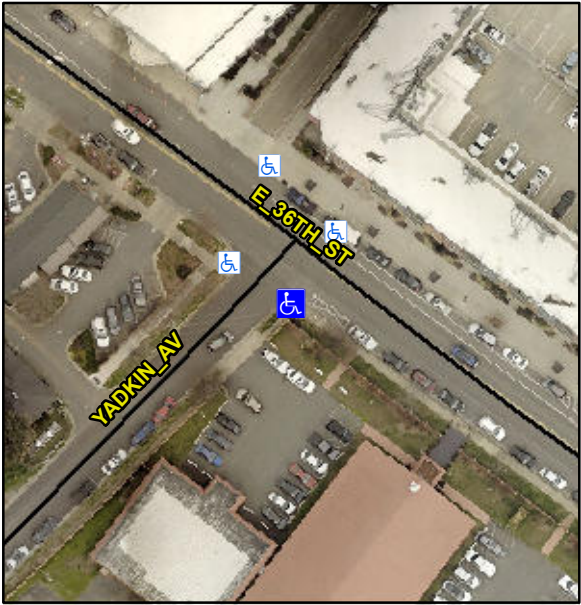
Possible Solutions:		<b>Compliance</b>	<b>Description</b>	<b>Data</b>
	<b>Remove &amp; Replace Curb Ramp With Two New Directional Ramps or Equivalent.</b>		<b>No</b>	Ramp Length (in)	<b>57.5</b>
			<b>No</b>	Ramp Width (in)	<b>47.5</b>
			<b>N/A</b>	Flare Type LT	<b>N/A</b>
			<b>N/A</b>	Flare Slope LT (%)	<b>N/A</b>
			<b>N/A</b>	Flare Traversable LT?	<b>N/A</b>
			<b>N/A</b>	Landing Length (in)	<b>N/A</b>
			<b>N/A</b>	Landing Width (in)	<b>N/A</b>
			<b>N/A</b>	Landing Slope (%)	<b>N/A</b>
			<b>N/A</b>	Landing X Slope (%)	<b>N/A</b>
<p>Surveyor Notes:</p> <p><b>N/A</b></p> <p>PROW/ADA:</p> <p><b>Not Found, R304.5.1, R304.2.2, R304.5.3</b></p>			<b>N/A</b>	Flare Type RT	<b>N/A</b>
			<b>N/A</b>	Flare Slope RT (%)	<b>N/A</b>
			<b>N/A</b>	Flare Traversable RT?	<b>N/A</b>
			<b>N/A</b>	DWS Provided?	<b>N/A</b>
			<b>N/A</b>	DWS Contrast?	<b>N/A</b>

<b>N/A</b>	DWS Length (in)	<b>N/A</b>
			<b>N/A</b>	DWS Full Width?	<b>N/A</b>
			<b>N/A</b>	DWS Offset (in)	<b>N/A</b>
			<b>N/A</b>	Gutter Slope (%)	<b>N/A</b>
			<b>N/A</b>	Gutter X Slope (%)	<b>N/A</b>
			<b>No</b>	Painted X Walk1?	<b>Yes</b>
				X Walk 1 Direction	<b>To NE</b>
			<b>N/A</b>	X Walk 1 Width (in)	<b>N/A</b>
			<b>4.2</b>	X Walk 1 Slope (%)	<b>2.5</b>
			<b>0.4</b>	X Walk 1 X Slope (%)	<b>0.1</b>
			<b>N/A</b>	Ramp inside XWalk1?	<b>Yes</b>
			<b>1.1</b>	Road Slope (%)	<b>N/A</b>
			<b>3.2</b>	Road X Slope (%)	<b>N/A</b>
			<b>N/A</b>	Any Obstructions?	<b>N/A</b>
				Obstruction Type	
Total Cost: \$ 3200.00			<b>N/A</b>	Storm Grate/Utility Hazard?	<b>N/A</b>
			<b>N/A</b>	Storm Grate/Utility Type	
			<b>Yes</b>	Surface Condition? (G/P)	<b>Good</b>
