Access Compliance Report

Public Rights-of-Way

(Curb Ramps)

Intersection ID: 8657	Main Street: HAINES_ST	Cross Street: ST_MARK_ST	Location: NW
ADA ID: 56398BD93BD0	Ramp Type: Perp	Initial Pass/Fail: Pass	Overall Compliance: No
		Severity Score: 0	
Codes/Mitigation Info/Possible Solution		Field Measurements/Component Compliance

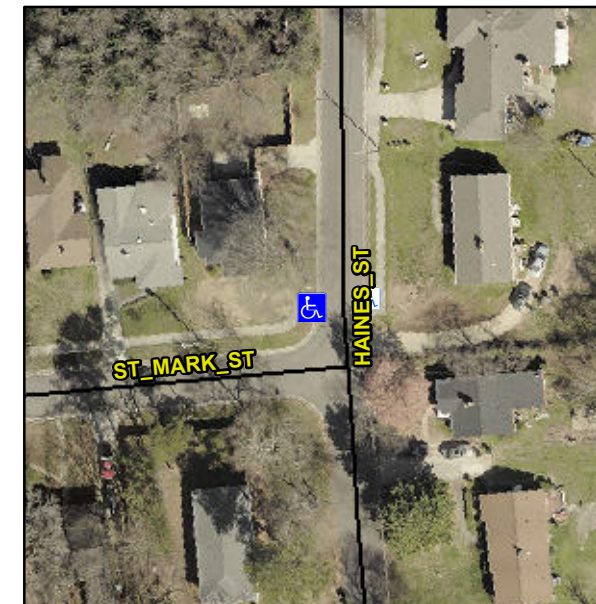
Not Found, R304.2.2-Perp, R304.3.2-Para

Compliance	Description	Data	Compliance	Description	Data
N/A	Ramp Length (in)	69.5	Yes	Ramp Slope (%)	5.6
Yes	Ramp Width (in)	48.0	Yes	Ramp XSlope (%)	0.9
N/A	Flare Type LT	Sloped	N/A	Flare Type RT	N/A
N/A	Flare Slope LT (%)	3.0	Yes	Flare Slope RT (%)	7.7
N/A	Flare Traversable LT?	Yes	N/A	Flare Traversable RT?	Yes
Yes	Landing Length (in)	61.0	Yes	DWS Provided?	Yes
Yes	Landing Width (in)	49.0	Yes	DWS Contrast?	Yes
No	Landing Slope (%)	2.9	Yes	DWS Length (in)	24.0
Yes	Landing X Slope (%)	0.1	Yes	DWS Full Width?	Yes
N/A	Landing Curb? (Y/N)	No	Yes	DWS Offset (in)	0.0
N/A	Shared Landing?	No			
Yes	Gutter Ponding?	No	Yes	Gutter Slope (%)	1.2
Yes	Gutter Lip Ht (in)	0.0	Yes	Gutter X Slope (%)	0.1
N/A	Painted X Walk1?	No	N/A	Painted X Walk2?	N/A
	X Walk 1 Direction	To E		X Walk 2 Direction	N/A
N/A	X Walk 1 Width (in)	N/A	N/A	X Walk 2 Width (in)	N/A
	X Walk 1 Slope (%)	2.7		X Walk 2 Slope (%)	N/A
	X Walk 1 X Slope (%)	2.1		X Walk 2 X Slope (%)	N/A

N/A	Ramp inside XWalk1?	N/A	N/A	Ramp inside XWalk2?	N/A
	Road Slope (%)	N/A	N/A	Clear Space?	Yes
	Road X Slope (%)	N/A	N/A	Clear Space to XWalk (in)	N/A
Yes	Any Obstructions?	No	Yes	Storm Grate/Utility Hazard?	No
	Obstruction Type			Storm Grate/Utility Type	
		N/A			N/A
			Yes	Surface Condition? (G/P)	Good

Remove & Replace Entire Ramp.
