Access Compliance Report

Public Rights-of-Way

(Curb Ramps)

Intersection ID: 12413	Main Street: N_BREVARD_ST	Cross Street: E_6TH_ST	Location: E
ADA ID: 563C7AA8A0D5	Ramp Type: PerpDiag	Initial Pass/Fail: Pass	Overall Compliance: No
Severity Score: 0.25			
Codes/Mitigation Info/Possible Solution		Field Measurements/Component Compliance

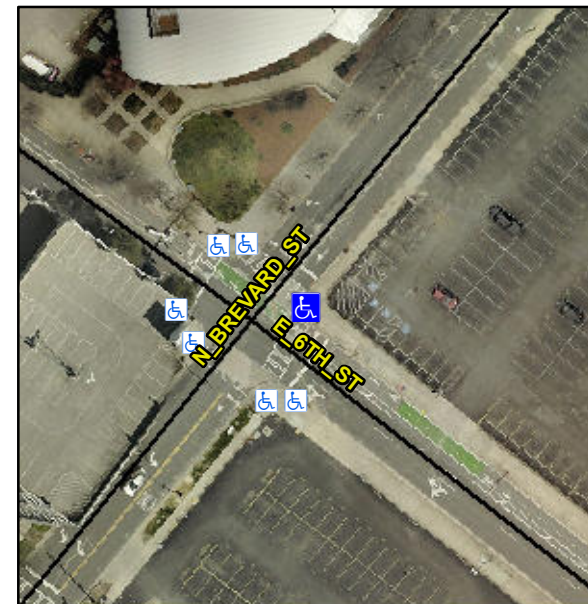
Compliance	Description	Data	Compliance	Description	Data
N/A	Ramp Length (in)	64.0	Yes	Ramp Slope (%)	7.5
Yes	Ramp Width (in)	48.0	Yes	Ramp XSlope (%)	3.3
N/A	Flare Type LT	Sloped	N/A	Flare Type RT	N/A
N/A	Flare Slope LT (%)	8.3	Yes	Flare Slope RT (%)	7.1
N/A	Flare Traversable LT?	Yes	N/A	Flare Traversable RT?	Yes
No	Landing Length (in)	48.0	Yes	DWS Provided?	Yes
Yes	Landing Width (in)	48.0	Yes	DWS Contrast?	Yes
No	Landing Slope (%)	3.7	Yes	DWS Length (in)	24.0
No	Landing X Slope (%)	3.8	Yes	DWS Full Width?	Yes
N/A	Landing Curb? (Y/N)	Yes	No	DWS Offset (in)	15.0
N/A	Shared Landing?	No			
Yes	Gutter Ponding?	No	Yes	Gutter Slope (%)	2.8
Yes	Gutter Lip Ht (in)	0.0	Yes	Gutter X Slope (%)	1.7
N/A	Painted X Walk1?	Yes	N/A	Painted X Walk2?	Yes
	X Walk 1 Direction	To NW		X Walk 2 Direction	To SW
N/A	X Walk 1 Width (in)	104.0	N/A	X Walk 2 Width (in)	108.0
	X Walk 1 Slope (%)	2.9		X Walk 2 Slope (%)	0.6
	X Walk 1 X Slope (%)	1.3		X Walk 2 X Slope (%)	1.6

Yes	Ramp inside XWalk1?	Yes	Yes	Ramp inside XWalk2?	Yes
	Road Slope (%)	3.3	N/A	Clear Space?	Yes
	Road X Slope (%)	1.1	Yes	Clear Space to XWalk (in)	48.0
Yes	Any Obstructions?	No	Yes	Storm Grate/Utility Hazard?	No
	Obstruction Type			Storm Grate/Utility Type	
		N/A			N/A
		Yes	Yes	Surface Condition? (G/P)	Good

Possible Solutions:

Remove & Replace Curb Ramp With Two New Directional Ramps or Equivalent.
