# Access Compliance Report

## Public Rights-of-Way

### (Curb Ramps)

Intersection ID: 54455	Main Street: COLLINGHAM_DR	Cross Street: RUPELL_DR	Location: SE
ADA ID: 564832658427	Ramp Type: BlendTrans1	Initial Pass/Fail: Fail	Overall Compliance: No
		Severity Score: 10

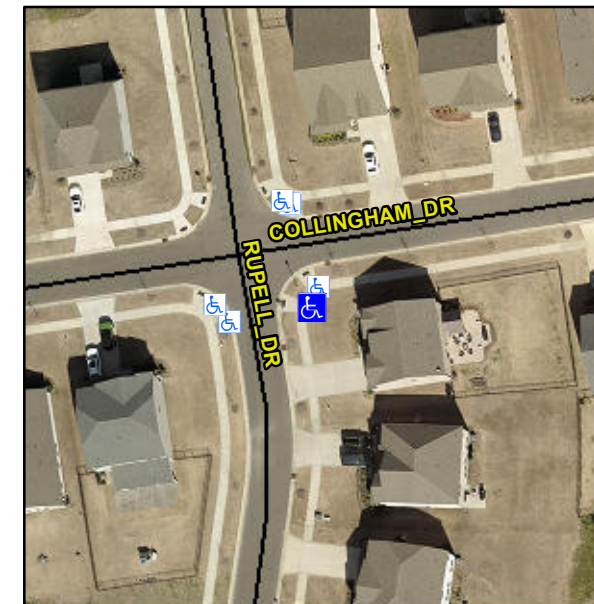
**Not Found, R304.5.1, R304.5.3**

Compliance	Description	Data	Compliance	Description	Data
N/A	Ramp Length (in)	109.0	Yes	BlendTrans Slope (%)	3.5
No	Ramp Width (in)	46.5	No	BlendTrans XSlope (%)	3.8
N/A	Flare Type LT	N/A	N/A	Flare Type RT	N/A
N/A	Flare Slope LT (%)	N/A	N/A	Flare Slope RT (%)	N/A
N/A	Flare Traversable LT?	N/A	N/A	Flare Traversable RT?	N/A
N/A	Landing Length (in)	N/A	N/A	DWS Provided?	N/A
N/A	Landing Width (in)	N/A	N/A	DWS Contrast?	N/A
N/A	Landing Slope (%)	N/A	N/A	DWS Length (in)	N/A
N/A	Landing X Slope (%)	N/A	N/A	DWS Full Width?	N/A
N/A	Landing Curb? (Y/N)	N/A	N/A	DWS Offset (in)	N/A
N/A	Shared Landing?	N/A			
N/A	Gutter Ponding?	N/A	N/A	Gutter Slope (%)	N/A
N/A	Gutter Lip Ht (in)	N/A	N/A	Gutter X Slope (%)	N/A
N/A	Painted X Walk1?	No	N/A	Painted X Walk2?	N/A
	X Walk 1 Direction	To SW		X Walk 2 Direction	N/A
	X Walk 1 Width (in)	N/A		X Walk 2 Width (in)	N/A
	X Walk 1 Slope (%)	1.7		X Walk 2 Slope (%)	N/A
	X Walk 1 X Slope (%)	2.7		X Walk 2 X Slope (%)	N/A

N/A	Ramp inside XWalk1?	N/A	N/A	Ramp inside XWalk2?	N/A
	Road Slope (%)	2.7		Clear Space?	N/A
	Road X Slope (%)	1.7	N/A	Clear Space to XWalk (in)	N/A
N/A	Any Obstructions?	N/A	N/A	Storm Grate/Utility Hazard?	N/A
	Obstruction Type			Storm Grate/Utility Type	
		N/A			N/A
			Yes	Surface Condition? (G/P)	Good
			No	Curb Slope (%)	9.5

**Remove & Replace Curb Ramp With Two New Directional Ramps or Equivalent.**
