## **Access Compliance Report Public Rights-of-Way** (Curb Ramps)

Intersection ID: 8369 Main Street: LASALLE ST **Cross Street: SENIOR DR** Location: NW Initial Pass/Fail: Fail **Overall Compliance: No** ADA ID: 564C37E7A86D Ramp Type: Combination1 Severity Score: 46.25

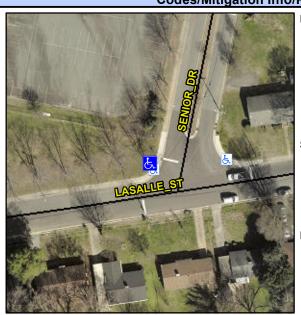
Street 1 Name StopSign Stop Condition-Street 1 SENIOR DR Street 2 Name N/A Stop Condition-Street 2 N/A Possible Solutions: Compliance Description N/A Remove & Replace Entire Ramp. No Yes No N/A No Surveyor Notes: N/A LT RP < 5% N/A N/A N/A N/A PROW/ADA: N/A Not Found, R304.5.1, R304.5.1, N/A R304.5.3, R304.3.2 N/A N/A N/A N/A N/A
