Access Compliance Report

Public Rights-of-Way

(Curb Ramps)

Intersection ID: 12335	Main Street: MORTON_ST	Cross Street: W_MOREHEAD_ST	Location:	N
ADA ID: 56540797391A	Ramp Type: PerpDiag	Initial Pass/Fail: Fail	Overall Compliance: No	Severity Score: 27.5
Codes/Mitigation Info/Possible Solution		Field Measurements/Component Compliance

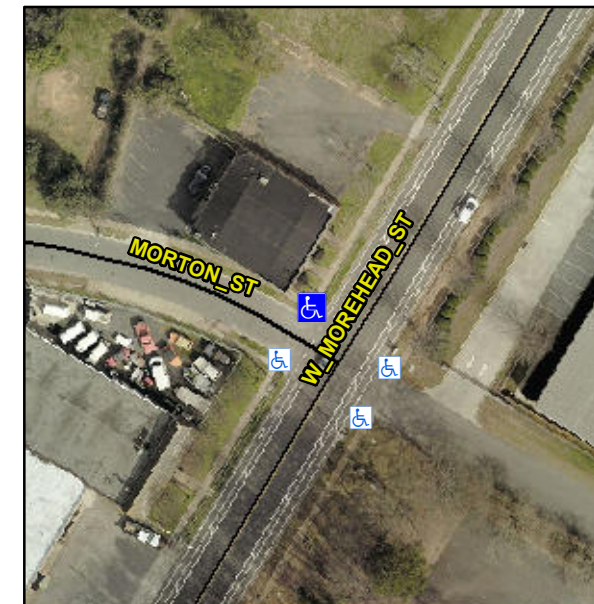
Compliance	Description	Data	Compliance	Description	Data
N/A	Ramp Length (in)	58.0	No	Ramp Slope (%)	9.2
Yes	Ramp Width (in)	52.0	Yes	Ramp XSlope (%)	1.4
N/A	Flare Type LT	N/A	N/A	Flare Type RT	N/A
N/A	Flare Slope LT (%)	N/A	N/A	Flare Slope RT (%)	N/A
N/A	Flare Traversable LT?	N/A	N/A	Flare Traversable RT?	N/A
N/A	Landing Length (in)	N/A	N/A	DWS Provided?	N/A
N/A	Landing Width (in)	N/A	N/A	DWS Contrast?	N/A
N/A	Landing Slope (%)	N/A	N/A	DWS Length (in)	N/A
N/A	Landing X Slope (%)	N/A	N/A	DWS Full Width?	N/A
N/A	Landing Curb? (Y/N)	N/A	N/A	DWS Offset (in)	N/A
N/A	Shared Landing?	N/A			
N/A	Gutter Ponding?	N/A	N/A	Gutter Slope (%)	N/A
N/A	Gutter Lip Ht (in)	N/A	N/A	Gutter X Slope (%)	N/A
N/A	Painted X Walk1?	No	N/A	Painted X Walk2?	No
	X Walk 1 Direction	To SW		X Walk 2 Direction	To SE
N/A	X Walk 1 Width (in)	N/A	N/A	X Walk 2 Width (in)	N/A
	X Walk 1 Slope (%)	3.0		X Walk 2 Slope (%)	4.6
	X Walk 1 X Slope (%)	2.7		X Walk 2 X Slope (%)	1.6

N/A	Ramp inside XWalk1?	N/A	N/A	Ramp inside XWalk2?	N/A
	Road Slope (%)	2.3	N/A	Clear Space?	N/A
	Road X Slope (%)	1.2	N/A	Clear Space to XWalk (in)	N/A
N/A	Any Obstructions?	N/A	N/A	Storm Grate/Utility Hazard?	N/A
	Obstruction Type			Storm Grate/Utility Type	
		N/A			N/A
		No		Surface Condition? (G/P)	Poor

Remove & Replace Curb Ramp With Two New Directional Ramps or Equivalent.

R304.2.2, R302.7
