Access Compliance Report Public Rights-of-Way (Curb Ramps)

Intersection ID: 2729 Main Street: FAIRVISTA_DR Cross Street: FAIRWAY_POINT_DR							Location	NE
			treet:		Location:	NE		
ADA ID: 56558AC0A301 Ramp Type: PerpDiag		Initial Pa	Initial Pass/Fail: Fail Overall Compliance: No				Severity Score:	21.25
Codes/Mitigation Info/Possible Solution			Field Measurements/Component Compliance

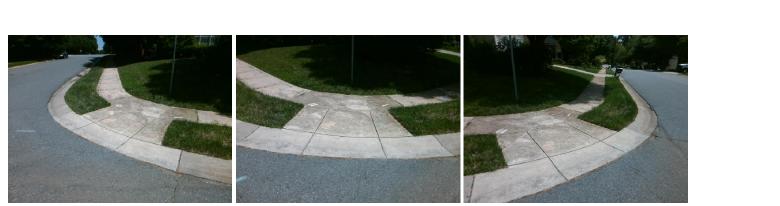
e.	Possible Solutions:		Compliance Description Date			a Compliance Description		Data
R. CONTOR	Remove & Replace Curb Ramp W Two New Directional Ramps or Equivalent.	Vith	N/A	Ramp Length (in)	46.0	Yes	Ramp Slope (%)	6.9
			No	Ramp Width (in)	40.0	No	Ramp XSlope (%)	5.5
			N/A	Flare Type LT	N/A	N/A	Flare Type RT	N/A
			N/A	Flare Slope LT (%)	N/A	N/A	Flare Slope RT (%)	N/A
			N/A	Flare Traversable LT?	N/A	N/A	Flare Traversable RT?	N/A
			N/A	Landing Length (in)	N/A	N/A	DWS Provided?	N/A
	Surveyor Notes:		N/A	Landing Width (in)	N/A	N/A	DWS Contrast?	N/A
	N/A		N/A	Landing Slope (%)	N/A	N/A	DWS Length (in)	N/A
			N/A	Landing X Slope (%)	N/A	N/A	DWS Full Width?	N/A
			N/A	Landing Curb? (Y/N)	N/A	N/A	DWS Offset (in)	N/A
			N/A	Shared Landing?	N/A			
	PROW/ADA:		N/A	Gutter Ponding?	N/A	N/A	Gutter Slope (%)	N/A
	Not Found, R304.5.1, R304.5.3		N/A	Gutter Lip Ht (in)	N/A	N/A	Gutter X Slope (%)	N/A
			N/A	Painted X Walk1?	No	N/A	Painted X Walk2?	No

X Walk 1 Direction	To W		X Walk 2 Direction	To S
			N/A	X Walk 1 Width (in)	N/A	N/A	X Walk 2 Width (in)	N/A
Street 1 Name FAIRVISTA DR				X Walk 1 Slope (%)	3.9		X Walk 2 Slope (%)	2.6
Stop Condition-Street 2 StopSign				X Walk 1 X Slope (%)	1.5		X Walk 2 X Slope (%)	2.9
Street 2 Name FAIRWAY POINT DR			N/A	Ramp inside XWalk1?	N/A	N/A	Ramp inside XWalk2?	N/A
Stop Condition-Street 1 None				Road Slope (%)	4.5	N/A	Clear Space?	N/A
				Road X Slope (%)	3.5	N/A	Clear Space to XWalk (in)	N/A
			N/A	Any Obstructions?	N/A	N/A	Storm Grate/Utility Hazard?	N/A
	Total Cost: \$ 32	200.00		Obstruction Type			Storm Grate/Utility Type	
					N/A			N/A
