Access Compliance Report Public Rights-of-Way (Curb Ramps)

Intersection ID: 10035065 Main Street: PROVIDENCE_RD Cross Street: N/A Location: SE

ADA ID: 565ADA2E5343 Ramp Type: PerpDiag Initial Pass/Fail: Fail Overall Compliance: No Severity Score: 13.75

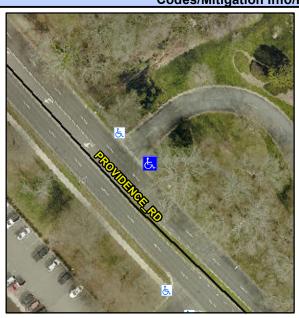
PROW/ADA:
Not Found, R304.2.2, R304.5.3

Field Measurements/Component Compliance						
	Compliance Description		Data	Compliance Description		Data
	N/A	Ramp Length (in)	51.0	No	Ramp Slope (%)	8.8
	Yes	Ramp Width (in)	64.0	No	Ramp XSlope (%)	3.7
	N/A	Flare Type LT	N/A	N/A	Flare Type RT	N/A
	N/A	Flare Slope LT (%)	N/A	N/A	Flare Slope RT (%)	N/A
	N/A	Flare Traversable LT?	N/A	N/A	Flare Traversable RT?	N/A
	N/A	Landing Length (in)	N/A	N/A	DWS Provided?	N/A
	N/A	Landing Width (in)	N/A	N/A	DWS Contrast?	N/A
	N/A	Landing Slope (%)	N/A	N/A	DWS Length (in)	N/A
	N/A	Landing X Slope (%)	N/A	N/A	DWS Full Width?	N/A
	N/A	Landing Curb? (Y/N)	N/A	N/A	DWS Offset (in)	N/A
	N/A	Shared Landing?	N/A			
	N/A	Gutter Ponding?	N/A	N/A	Gutter Slope (%)	N/A
	N/A	Gutter Lip Ht (in)	N/A	N/A	Gutter X Slope (%)	N/A
	N/A	Painted X Walk1?	No	N/A	Painted X Walk2?	No
		X Walk 1 Direction	To N		X Walk 2 Direction	To W
	N/A	X Walk 1 Width (in)	N/A	N/A	X Walk 2 Width (in)	N/A
		X Walk 1 Slope (%)	0.6		X Walk 2 Slope (%)	5.0

X Walk 1 X Slope (%)	4.3		X Walk 2 X Slope (%)	1.7
	N/A	Ramp inside XWalk1?	N/A	N/A	Ramp inside XWalk2?	N/A
		Road Slope (%)	5.1	N/A	Clear Space?	N/A
		Road X Slope (%)	2.1	N/A	Clear Space to XWalk (in)	N/A
	N/A	Any Obstructions?	N/A	N/A	Storm Grate/Utility Hazard?	N/A
		Obstruction Type			Storm Grate/Utility Type	
			N/A			N/A
				Yes	Surface Condition? (G/P)	Good
1	TAK 3	A Property Control of the Control of

Remove & Replace Curb Ramp With
Two New Directional Ramps or
Equivalent.

Total Cost: \$ 3200.00
