Access Compliance Report

Public Rights-of-Way (Curb Ramps)

Intersection ID: 26060	Main Street: FLOWERING_DOGWOOD_LN	Cross Street: PROVIDENCE_GLEN_RD	Location: E
ADA ID: 5665C14585AE	Ramp Type: Perp	Initial Pass/Fail: Fail	Overall Compliance: No
Codes/Mitigation Info/Possible Solution		Field Measurements/Component Compliance	
Severity Score: 46.25

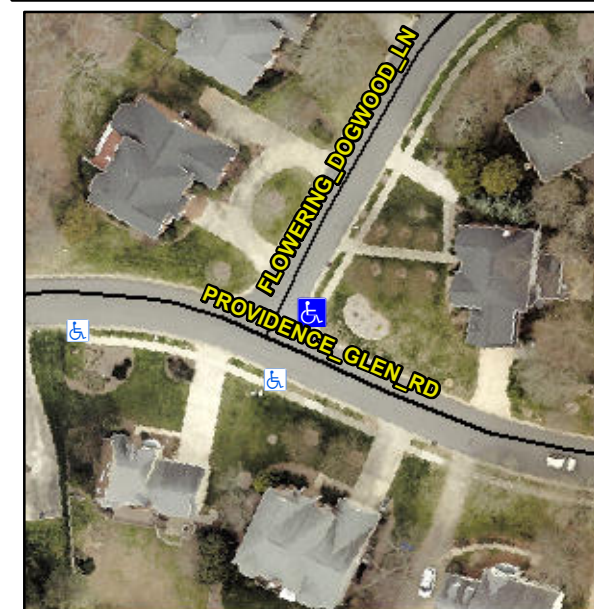
Not Found, R304.5.1, R304.2.2, R304.5.3

Compliance	Description	Data	Compliance	Description	Data
N/A	Ramp Length (in)	59.0	No	Ramp Slope (%)	12.6
No	Ramp Width (in)	47.0	No	Ramp XSlope (%)	6.0
N/A	Flare Type LT	N/A	N/A	Flare Type RT	N/A
N/A	Flare Slope LT (%)	N/A	N/A	Flare Slope RT (%)	N/A
N/A	Flare Traversable LT?	N/A	N/A	Flare Traversable RT?	N/A
N/A	Landing Length (in)	N/A	N/A	DWS Provided?	N/A
N/A	Landing Width (in)	N/A	N/A	DWS Contrast?	N/A
N/A	Landing Slope (%)	N/A	N/A	DWS Length (in)	N/A
N/A	Landing X Slope (%)	N/A	N/A	DWS Full Width?	N/A
N/A	Landing Curb? (Y/N)	N/A	N/A	DWS Offset (in)	N/A
N/A	Shared Landing?	N/A			
N/A	Gutter Ponding?	N/A	N/A	Gutter Slope (%)	N/A
N/A	Gutter Lip Ht (in)	N/A	N/A	Gutter X Slope (%)	N/A
N/A	Painted X Walk1?	No	N/A	Painted X Walk2?	N/A
	X Walk 1 Direction	To S		X Walk 2 Direction	N/A
N/A	X Walk 1 Width (in)	N/A	N/A	X Walk 2 Width (in)	N/A
	X Walk 1 Slope (%)	1.5		X Walk 2 Slope (%)	N/A
	X Walk 1 X Slope (%)	0.1		X Walk 2 X Slope (%)	N/A

N/A	Ramp inside XWalk1?	N/A	N/A	Ramp inside XWalk2?	N/A
	Road Slope (%)	N/A	N/A	Clear Space?	N/A
	Road X Slope (%)	N/A	N/A	Clear Space to XWalk (in)	N/A
N/A	Any Obstructions?	N/A	N/A	Storm Grate/Utility Hazard?	N/A
	Obstruction Type			Storm Grate/Utility Type	
		N/A			N/A
			Yes	Surface Condition? (G/P)	Good

Possible Solutions:

Remove & Replace Entire Ramp.
