# Access Compliance Report

## Public Rights-of-Way

### (Curb Ramps)

Intersection ID: 4659	Main Street: ASTORIA_DR	Cross Street: HARRIS_HOUSTON_RD	Location:	N
ADA ID: 566EA99BE8CA	Ramp Type: Perp	Initial Pass/Fail: Fail	Overall Compliance: No	Severity Score: 25

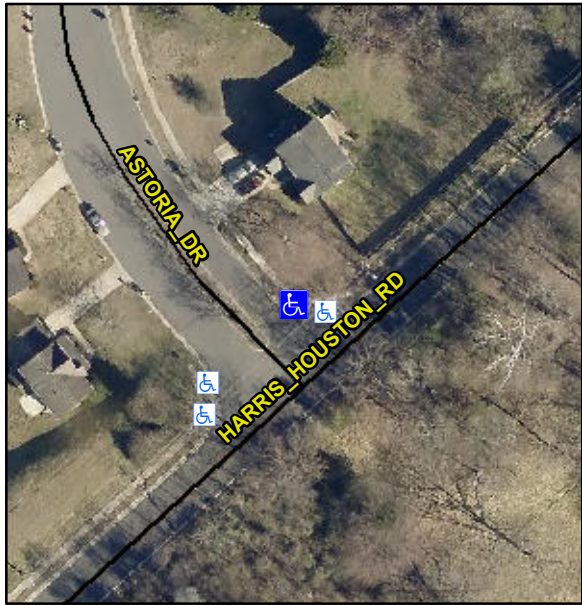
Possible Solutions:		Compliance	Description	Data	Compliance	Description	Data
	Remove & Replace Entire Ramp.		N/A	Ramp Length (in)	45.0	No	Ramp Slope (%)	8.7
			Yes	Ramp Width (in)	53.0	No	Ramp XSlope (%)	6.0
			N/A	Flare Type LT	N/A	N/A	Flare Type RT	N/A
			N/A	Flare Slope LT (%)	N/A	N/A	Flare Slope RT (%)	N/A
			N/A	Flare Traversable LT?	N/A	N/A	Flare Traversable RT?	N/A
			N/A	Landing Length (in)	N/A	N/A	DWS Provided?	N/A
			N/A	Landing Width (in)	N/A	N/A	DWS Contrast?	N/A
			N/A	Landing Slope (%)	N/A	N/A	DWS Length (in)	N/A
			N/A	Landing X Slope (%)	N/A	N/A	DWS Full Width?	N/A
Surveyor Notes:			N/A	Landing Curb? (Y/N)	N/A	N/A	DWS Offset (in)	N/A
N/A			N/A	Shared Landing?	N/A			
PROW/ADA:			N/A	Gutter Ponding?	N/A	N/A	Gutter Slope (%)	N/A
R304.2.2, R304.5.3			N/A	Gutter Lip Ht (in)	N/A	N/A	Gutter X Slope (%)	N/A

N/A	Painted X Walk1?	No	N/A	Painted X Walk2?	N/A
				X Walk 1 Direction	To SW		X Walk 2 Direction	N/A
			N/A	X Walk 1 Width (in)	N/A	N/A	X Walk 2 Width (in)	N/A
				X Walk 1 Slope (%)	9.4		X Walk 2 Slope (%)	N/A
				X Walk 1 X Slope (%)	1.5		X Walk 2 X Slope (%)	N/A
			N/A	Ramp inside XWalk1?	N/A	N/A	Ramp inside XWalk2?	N/A
				Road Slope (%)	N/A	N/A	Clear Space?	N/A
				Road X Slope (%)	N/A	N/A	Clear Space to XWalk (in)	N/A
			N/A	Any Obstructions?	N/A	N/A	Storm Grate/Utility Hazard?	N/A
				Obstruction Type			Storm Grate/Utility Type	
					N/A			N/A
						Yes	Surface Condition? (G/P)	Good
Total Cost:		\$ 1850.00						
Street 1 Name		ASTORIA DR						
Stop Condition-Street 2		StopSign						
Street 2 Name		N/A						
Stop Condition-Street 1		N/A
