Access Compliance Report

Public Rights-of-Way

(Curb Ramps)

Intersection ID: 31352	Main Street: MCINTYRE_RIDGE_DR	Cross Street: TRULL_ST	Location: SW
ADA ID: 568C324E4103	Ramp Type: BlendTrans1	Initial Pass/Fail: Fail	Overall Compliance: No
			Severity Score: 33.75

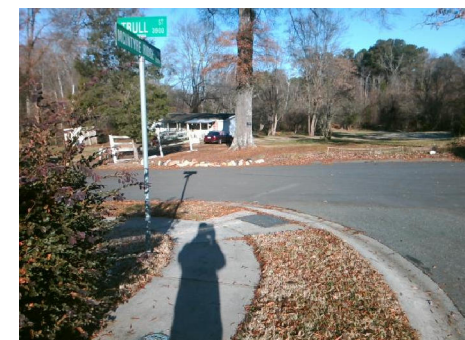
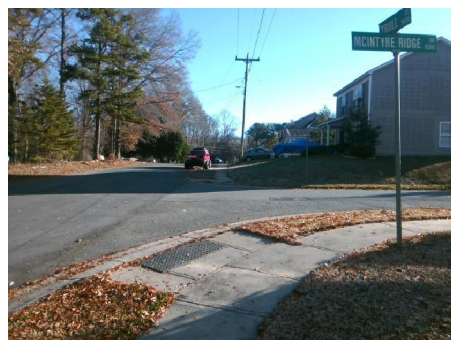
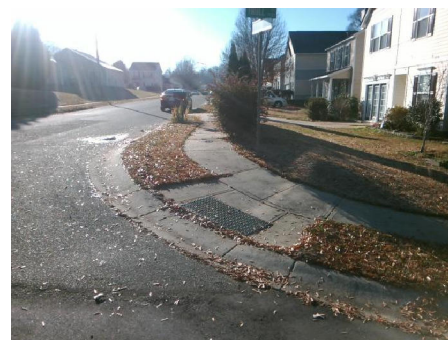
Not Found, R304.5.1, R304.5.3

Compliance	Description	Data	Compliance	Description	Data
N/A	Ramp Length (in)	46.0	Yes	BlendTrans Slope (%)	2.2
No	Ramp Width (in)	42.0	No	BlendTrans XSlope (%)	15.0
N/A	Flare Type LT	N/A	N/A	Flare Type RT	N/A
N/A	Flare Slope LT (%)	N/A	N/A	Flare Slope RT (%)	N/A
N/A	Flare Traversable LT?	N/A	N/A	Flare Traversable RT?	N/A
N/A	Landing Length (in)	N/A	N/A	DWS Provided?	N/A
N/A	Landing Width (in)	N/A	N/A	DWS Contrast?	N/A
N/A	Landing Slope (%)	N/A	N/A	DWS Length (in)	N/A
N/A	Landing X Slope (%)	N/A	N/A	DWS Full Width?	N/A
N/A	Landing Curb? (Y/N)	N/A	N/A	DWS Offset (in)	N/A
N/A	Shared Landing?	N/A			
N/A	Gutter Ponding?	N/A	N/A	Gutter Slope (%)	N/A
N/A	Gutter Lip Ht (in)	N/A	N/A	Gutter X Slope (%)	N/A
N/A	Painted X Walk1?	No	N/A	Painted X Walk2?	N/A
	X Walk 1 Direction	To NE		X Walk 2 Direction	N/A
	X Walk 1 Width (in)	N/A		X Walk 2 Width (in)	N/A
	X Walk 1 Slope (%)	3.0		X Walk 2 Slope (%)	N/A
	X Walk 1 X Slope (%)	1.9		X Walk 2 X Slope (%)	N/A

N/A	Ramp inside XWalk1?	N/A	N/A	Ramp inside XWalk2?	N/A
	Road Slope (%)	1.9		Clear Space?	N/A
	Road X Slope (%)	3.0	N/A	Clear Space to XWalk (in)	N/A
N/A	Any Obstructions?	N/A	N/A	Storm Grate/Utility Hazard?	N/A
	Obstruction Type			Storm Grate/Utility Type	
		N/A			N/A
			Yes	Surface Condition? (G/P)	Good
			No	Curb Slope (%)	13.8

Remove & Replace Curb Ramp With Two New Directional Ramps or Equivalent.
