# Access Compliance Report

## Public Rights-of-Way

### (Curb Ramps)

Intersection ID: 7563	Main Street: WALDON_RD	Cross Street: SHARPES_CR	Location: SW
ADA ID: 5690A0338B8C	Ramp Type: Perp	Initial Pass/Fail: Fail	Overall Compliance: No
Severity Score: 8.75			
Codes/Mitigation Info/Possible Solution		Field Measurements/Component Compliance

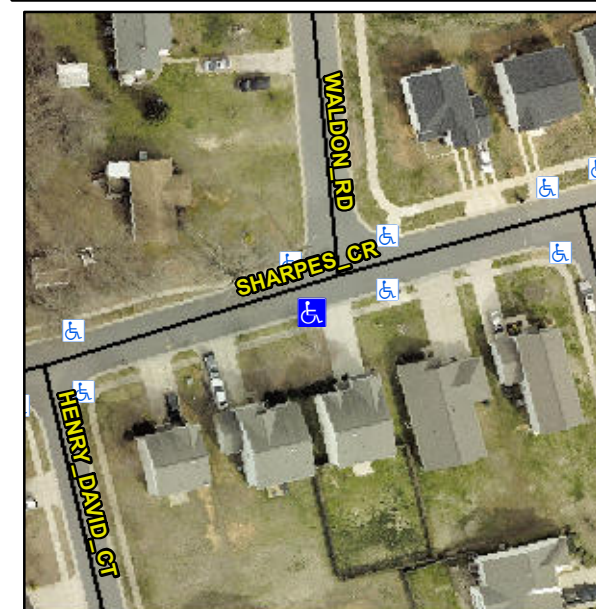
Compliance	Description	Data	Compliance	Description	Data
N/A	Ramp Length (in)	49.0	Yes	Ramp Slope (%)	5.5
No	Ramp Width (in)	47.5	Yes	Ramp XSlope (%)	1.5
N/A	Flare Type LT	N/A	N/A	Flare Type RT	N/A
N/A	Flare Slope LT (%)	N/A	N/A	Flare Slope RT (%)	N/A
N/A	Flare Traversable LT?	N/A	N/A	Flare Traversable RT?	N/A
N/A	Landing Length (in)	N/A	N/A	DWS Provided?	N/A
N/A	Landing Width (in)	N/A	N/A	DWS Contrast?	N/A
N/A	Landing Slope (%)	N/A	N/A	DWS Length (in)	N/A
N/A	Landing X Slope (%)	N/A	N/A	DWS Full Width?	N/A
N/A	Landing Curb? (Y/N)	N/A	N/A	DWS Offset (in)	N/A
N/A	Shared Landing?	N/A			
N/A	Gutter Ponding?	N/A	N/A	Gutter Slope (%)	N/A
N/A	Gutter Lip Ht (in)	N/A	N/A	Gutter X Slope (%)	N/A
N/A	Painted X Walk1?	No	N/A	Painted X Walk2?	N/A
	X Walk 1 Direction	To N		X Walk 2 Direction	N/A
N/A	X Walk 1 Width (in)	N/A	N/A	X Walk 2 Width (in)	N/A
	X Walk 1 Slope (%)	6.5		X Walk 2 Slope (%)	N/A
	X Walk 1 X Slope (%)	2.9		X Walk 2 X Slope (%)	N/A

N/A	Ramp inside XWalk1?	N/A	N/A	Ramp inside XWalk2?	N/A
	Road Slope (%)	N/A	N/A	Clear Space?	N/A
	Road X Slope (%)	N/A	N/A	Clear Space to XWalk (in)	N/A
N/A	Any Obstructions?	N/A	N/A	Storm Grate/Utility Hazard?	N/A
	Obstruction Type			Storm Grate/Utility Type	
		N/A			N/A
			Yes	Surface Condition? (G/P)	Good

Possible Solutions:

**Remove & Replace Entire Ramp.**

**Not Found, R304.5.1**
