Access Compliance Report

Public Rights-of-Way

(Curb Ramps)

Intersection ID: 14508	Main Street: CLANCY_PL	Cross Street: DWIGHTWARE_BV	Location: NW
ADA ID: 5690F0A3CCEA	Ramp Type: Para	Initial Pass/Fail: Fail	Overall Compliance: No
			Severity Score: 13.75

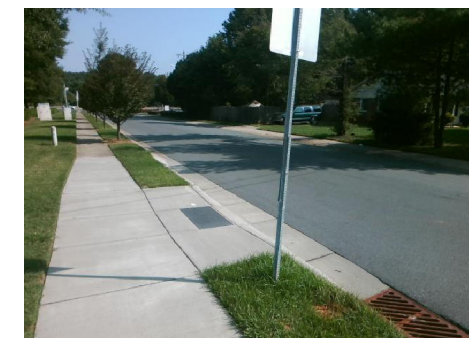
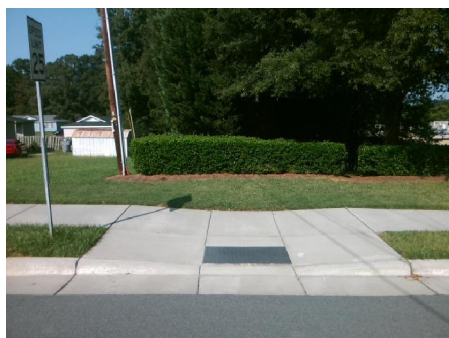
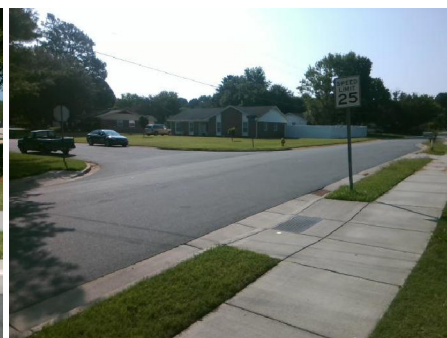
RT RP < 5%

R304.3.2, R304.5.3

Compliance	Description	Data	Compliance	Description	Data
N/A	Ramp Length LT (in)	64.0	N/A	Ramp Length RT (in)	59.0
Yes	Ramp Width LT (in)	60.0	Yes	Ramp Width RT (in)	60.0
No	Ramp Slope LT (%)	9.9	Yes	Ramp Slope RT (%)	4.8
No	Ramp XSlope LT (%)	2.3	No	Ramp XSlope RT (%)	2.6
N/A	Landing Length (in)	N/A	N/A	DWS Provided?	N/A
N/A	Landing Width (in)	N/A	N/A	DWS Contrast?	N/A
N/A	Landing Slope (%)	N/A	N/A	DWS Length (in)	N/A
N/A	Landing X Slope (%)	N/A	N/A	DWS Full Width?	N/A
N/A	Landing Curb? (Y/N)	N/A	N/A	DWS Offset (in)	N/A
N/A	Shared Landing?	N/A			
N/A	Gutter Ponding?	N/A	N/A	Gutter Slope (%)	N/A
N/A	Gutter Lip Ht (in)	N/A	N/A	Gutter X Slope (%)	N/A
N/A	Painted X Walk1?	No	N/A	Painted X Walk2?	N/A
	X Walk 1 Direction	To E		X Walk 2 Direction	N/A
N/A	X Walk 1 Width (in)	N/A	N/A	X Walk 2 Width (in)	N/A
	X Walk 1 Slope (%)	3.4		X Walk 2 Slope (%)	N/A
	X Walk 1 X Slope (%)	2.1		X Walk 2 X Slope (%)	N/A
N/A	Ramp inside XWalk1?	N/A	N/A	Ramp inside XWalk2?	N/A

Remove & Replace Entire Ramp.
