Access Compliance Report

Public Rights-of-Way

(Curb Ramps)

Intersection ID: 50600	Main Street: BENDING_BRANCH_RD	Cross Street: HEARTLEAF_RD	Location: W
ADA ID: 569C53F5A289	Ramp Type: Perp	Initial Pass/Fail: Fail	Overall Compliance: No
Severity Score: 8.75			
Codes/Mitigation Info/Possible Solution		Field Measurements/Component Compliance

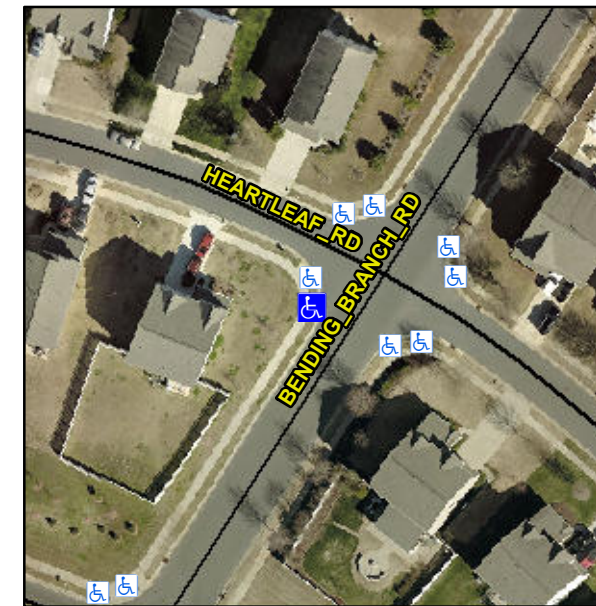
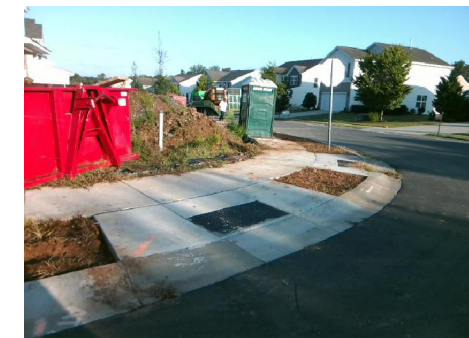
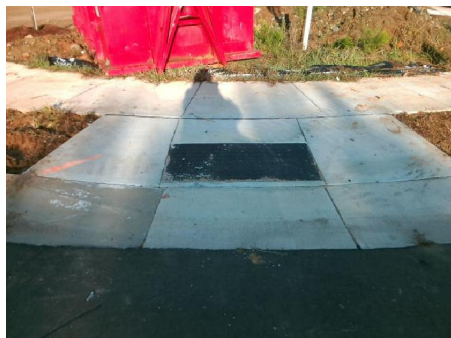
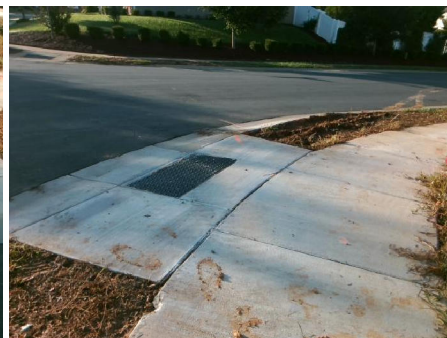
Not Found, R304.5.1

Compliance	Description	Data	Compliance	Description	Data
N/A	Ramp Length (in)	47.5	Yes	Ramp Slope (%)	6.6
No	Ramp Width (in)	46.0	Yes	Ramp XSlope (%)	0.7
N/A	Flare Type LT	N/A	N/A	Flare Type RT	N/A
N/A	Flare Slope LT (%)	N/A	N/A	Flare Slope RT (%)	N/A
N/A	Flare Traversable LT?	N/A	N/A	Flare Traversable RT?	N/A
N/A	Landing Length (in)	N/A	N/A	DWS Provided?	N/A
N/A	Landing Width (in)	N/A	N/A	DWS Contrast?	N/A
N/A	Landing Slope (%)	N/A	N/A	DWS Length (in)	N/A
N/A	Landing X Slope (%)	N/A	N/A	DWS Full Width?	N/A
N/A	Landing Curb? (Y/N)	N/A	N/A	DWS Offset (in)	N/A
N/A	Shared Landing?	N/A			
N/A	Gutter Ponding?	N/A	N/A	Gutter Slope (%)	N/A
N/A	Gutter Lip Ht (in)	N/A	N/A	Gutter X Slope (%)	N/A
N/A	Painted X Walk1?	No	N/A	Painted X Walk2?	N/A
	X Walk 1 Direction	To SE		X Walk 2 Direction	N/A
N/A	X Walk 1 Width (in)	N/A	N/A	X Walk 2 Width (in)	N/A
	X Walk 1 Slope (%)	1.5		X Walk 2 Slope (%)	N/A
	X Walk 1 X Slope (%)	2.2		X Walk 2 X Slope (%)	N/A

N/A	Ramp inside XWalk1?	N/A	N/A	Ramp inside XWalk2?	N/A
	Road Slope (%)	N/A	N/A	Clear Space?	N/A
	Road X Slope (%)	N/A	N/A	Clear Space to XWalk (in)	N/A
N/A	Any Obstructions?	N/A	N/A	Storm Grate/Utility Hazard?	N/A
	Obstruction Type			Storm Grate/Utility Type	
		N/A			N/A
			Yes	Surface Condition? (G/P)	Good

Remove & Replace Entire Ramp.

Total Cost: \$ 1850.00
