Access Compliance Report

Public Rights-of-Way

(Curb Ramps)

Intersection ID: 13296	Main Street: CENTRAL_AV	Cross Street: MORNINGSIDE_DR	Location: SE
ADA ID: 569E109BD2AC	Ramp Type: Perp	Initial Pass/Fail: Fail	Overall Compliance: No
		Severity Score: 8.75

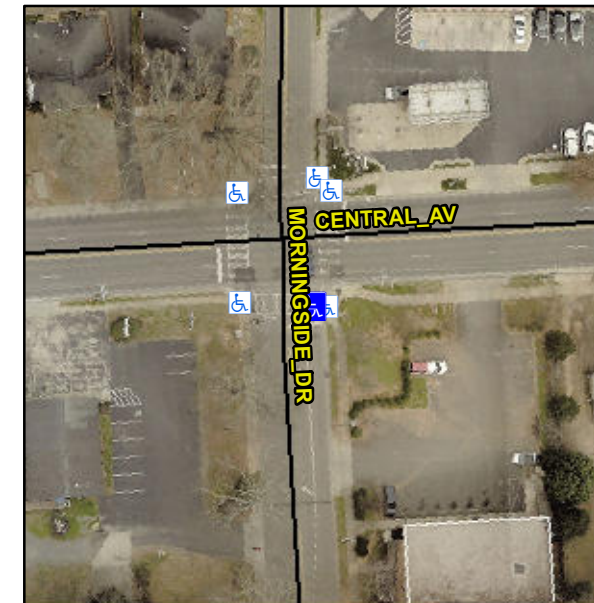
Not Found, R304.5.1

Compliance	Description	Data	Compliance	Description	Data
N/A	Ramp Length (in)	37.0	Yes	Ramp Slope (%)	6.4
No	Ramp Width (in)	39.0	Yes	Ramp XSlope (%)	1.5
N/A	Flare Type LT	N/A	N/A	Flare Type RT	N/A
N/A	Flare Slope LT (%)	N/A	N/A	Flare Slope RT (%)	N/A
N/A	Flare Traversable LT?	N/A	N/A	Flare Traversable RT?	N/A
N/A	Landing Length (in)	N/A	N/A	DWS Provided?	N/A
N/A	Landing Width (in)	N/A	N/A	DWS Contrast?	N/A
N/A	Landing Slope (%)	N/A	N/A	DWS Length (in)	N/A
N/A	Landing X Slope (%)	N/A	N/A	DWS Full Width?	N/A
N/A	Landing Curb? (Y/N)	N/A	N/A	DWS Offset (in)	N/A
N/A	Shared Landing?	N/A			
N/A	Gutter Ponding?	N/A	N/A	Gutter Slope (%)	N/A
N/A	Gutter Lip Ht (in)	N/A	N/A	Gutter X Slope (%)	N/A
N/A	Painted X Walk1?	Yes	N/A	Painted X Walk2?	N/A
	X Walk 1 Direction	To W		X Walk 2 Direction	N/A
N/A	X Walk 1 Width (in)	111.0	N/A	X Walk 2 Width (in)	N/A
	X Walk 1 Slope (%)	4.5		X Walk 2 Slope (%)	N/A
	X Walk 1 X Slope (%)	2.2		X Walk 2 X Slope (%)	N/A

N/A	Ramp inside XWalk1?	Yes	N/A	Ramp inside XWalk2?	N/A
	Road Slope (%)	N/A	N/A	Clear Space?	N/A
	Road X Slope (%)	N/A	N/A	Clear Space to XWalk (in)	N/A
N/A	Any Obstructions?	N/A	N/A	Storm Grate/Utility Hazard?	N/A
	Obstruction Type			Storm Grate/Utility Type	
		N/A			N/A
			Yes	Surface Condition? (G/P)	Good

Remove & Replace Entire Ramp.

Total Cost: \$ 1850.00
