Access Compliance Report Public Rights-of-Way (Curb Ramps)

Intersection ID: 10037210 Main Street: SANDY_ROCK_PL **Cross Street: N/A** Location: SE ADA ID: 56B32BD36394 Ramp Type: PerpDiag Initial Pass/Fail: Fail **Overall Compliance: No Severity Score:** 12.5

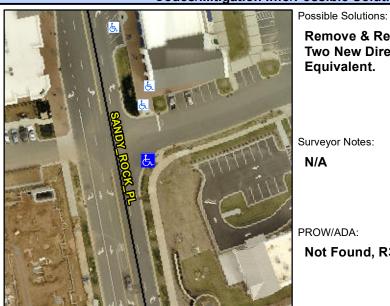
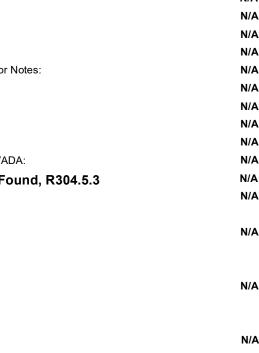
Field Measurements/Component Compnance					
Compliance Description		Data	Compliance Description		Data
N/A	Ramp Length (in)	95.0	Yes	Ramp Slope (%)	5.7
Yes	Ramp Width (in)	60.5	No	Ramp XSlope (%)	6.8
N/A	Flare Type LT	N/A	N/A	Flare Type RT	N/A
N/A	Flare Slope LT (%)	N/A	N/A	Flare Slope RT (%)	N/A
N/A	Flare Traversable LT?	N/A	N/A	Flare Traversable RT?	N/A
N/A	Landing Length (in)	N/A	N/A	DWS Provided?	N/A
N/A	Landing Width (in)	N/A	N/A	DWS Contrast?	N/A
N/A	Landing Slope (%)	N/A	N/A	DWS Length (in)	N/A
N/A	Landing X Slope (%)	N/A	N/A	DWS Full Width?	N/A
N/A	Landing Curb? (Y/N)	N/A	N/A	DWS Offset (in)	N/A
N/A	Shared Landing?	N/A			
N/A	Gutter Ponding?	N/A	N/A	Gutter Slope (%)	N/A
N/A	Gutter Lip Ht (in)	N/A	N/A	Gutter X Slope (%)	N/A
N/A	Painted X Walk1?	No	N/A	Painted X Walk2?	No
	X Walk 1 Direction	To N		X Walk 2 Direction	To W
N/A	X Walk 1 Width (in)	N/A	N/A	X Walk 2 Width (in)	N/A
	X Walk 1 Slope (%)	3.1		X Walk 2 Slope (%)	2.8

X Walk 1 X Slope (%)	2.8		X Walk 2 X Slope (%)	1.7
N/A	Ramp inside XWalk1?	N/A	N/A	Ramp inside XWalk2?	N/A
	Road Slope (%)	3.1	N/A	Clear Space?	N/A
	Road X Slope (%)	3.2	N/A	Clear Space to XWalk (in)	N/A
N/A	Any Obstructions?	N/A	N/A	Storm Grate/Utility Hazard?	N/A
	Obstruction Type			Storm Grate/Utility Type	
		N/A			N/A
			Yes	Surface Condition? (G/P)	Good

Remove & Replace Curb Ramp With Two New Directional Ramps or Equivalent. Surveyor Notes: N/A PROW/ADA:

Not Found, R304.5.3
