Access Compliance Report

Public Rights-of-Way

(Curb Ramps)

Intersection ID: 50588	Main Street: BENDING_BRANCH_RD	Cross Street: DOWNY_BIRCH_RD	Location: SE
ADA ID: 56B7B3C8E8F1	Ramp Type: Perp	Initial Pass/Fail: Fail	Overall Compliance: No
Severity Score: 22.5

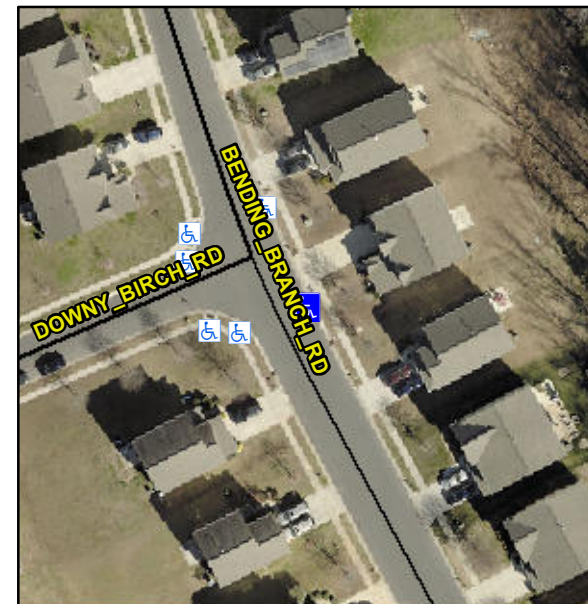
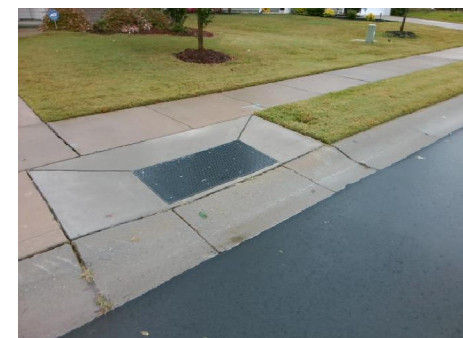
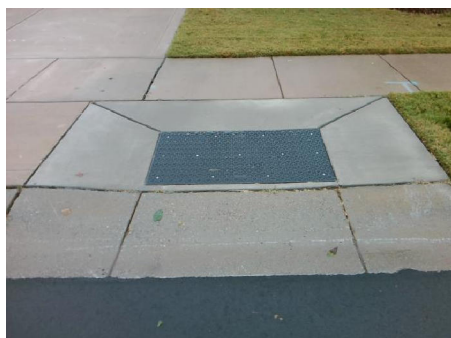
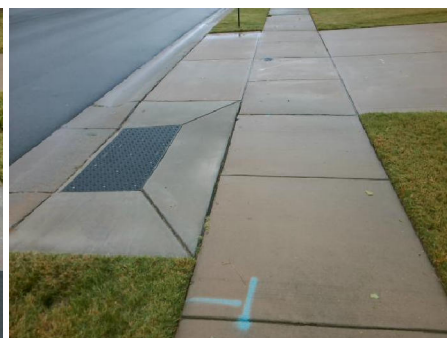
Not Found, R304.5.1, R304.2.2, R304.5.3

Compliance	Description	Data	Compliance	Description	Data
N/A	Ramp Length (in)	48.0	No	Ramp Slope (%)	10.6
No	Ramp Width (in)	47.5	No	Ramp XSlope (%)	2.7
N/A	Flare Type LT	N/A	N/A	Flare Type RT	N/A
N/A	Flare Slope LT (%)	N/A	N/A	Flare Slope RT (%)	N/A
N/A	Flare Traversable LT?	N/A	N/A	Flare Traversable RT?	N/A
N/A	Landing Length (in)	N/A	N/A	DWS Provided?	N/A
N/A	Landing Width (in)	N/A	N/A	DWS Contrast?	N/A
N/A	Landing Slope (%)	N/A	N/A	DWS Length (in)	N/A
N/A	Landing X Slope (%)	N/A	N/A	DWS Full Width?	N/A
N/A	Landing Curb? (Y/N)	N/A	N/A	DWS Offset (in)	N/A
N/A	Shared Landing?	N/A			
N/A	Gutter Ponding?	N/A	N/A	Gutter Slope (%)	N/A
N/A	Gutter Lip Ht (in)	N/A	N/A	Gutter X Slope (%)	N/A
N/A	Painted X Walk1?	No	N/A	Painted X Walk2?	N/A
	X Walk 1 Direction	To W		X Walk 2 Direction	N/A
N/A	X Walk 1 Width (in)	N/A	N/A	X Walk 2 Width (in)	N/A
	X Walk 1 Slope (%)	3.1		X Walk 2 Slope (%)	N/A
	X Walk 1 X Slope (%)	2.0		X Walk 2 X Slope (%)	N/A

N/A	Ramp inside XWalk1?	N/A	N/A	Ramp inside XWalk2?	N/A
	Road Slope (%)	N/A	N/A	Clear Space?	N/A
	Road X Slope (%)	N/A	N/A	Clear Space to XWalk (in)	N/A
N/A	Any Obstructions?	N/A	N/A	Storm Grate/Utility Hazard?	N/A
	Obstruction Type			Storm Grate/Utility Type	
		N/A			N/A
			Yes	Surface Condition? (G/P)	Good

Remove & Replace Entire Ramp.
