Access Compliance Report

Public Rights-of-Way

(Curb Ramps)

Intersection ID: 10020701	Main Street: BEATTIES_FORD_RD	Cross Street: N/A	Location: W
ADA ID: 56B7BA7B812D	Ramp Type: Perp	Initial Pass/Fail: Pass	Overall Compliance: No
			Severity Score: 40

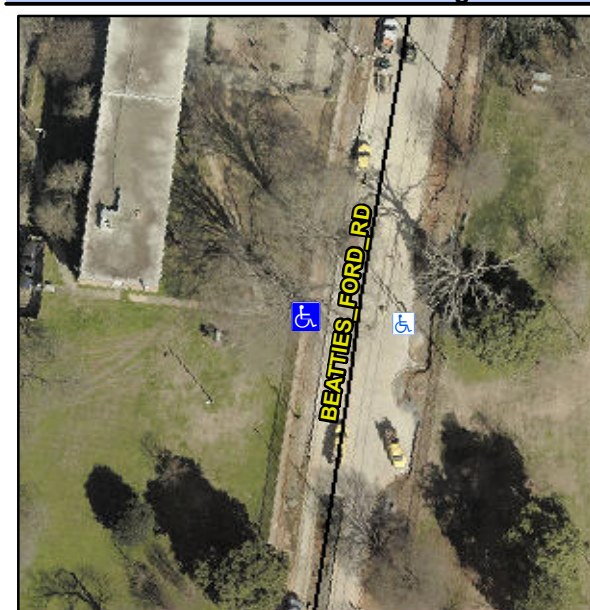
Compliance	Description	Data	Compliance	Description	Data
N/A	Ramp Length (in)	76.0	Yes	Ramp Slope (%)	5.8
Yes	Ramp Width (in)	48.0	Yes	Ramp XSlope (%)	0.8
N/A	Flare Type LT	None	N/A	Flare Type RT	N/A
N/A	Flare Slope LT (%)	N/A	N/A	Flare Slope RT (%)	N/A
N/A	Flare Traversable LT?	N/A	N/A	Flare Traversable RT?	N/A
No	Landing Length (in)	N/A	No	DWS Provided?	No
No	Landing Width (in)	N/A	N/A	DWS Contrast?	No
No	Landing Slope (%)	N/A	N/A	DWS Length (in)	N/A
No	Landing X Slope (%)	N/A	N/A	DWS Full Width?	No
N/A	Landing Curb? (Y/N)	No	N/A	DWS Offset (in)	N/A
N/A	Shared Landing?	No			
Yes	Gutter Ponding?	No	No	Gutter Slope (%)	6.4
No	Gutter Lip Ht (in)	1.5	Yes	Gutter X Slope (%)	1.3
N/A	Painted X Walk1?	No	N/A	Painted X Walk2?	N/A
	X Walk 1 Direction	To E		X Walk 2 Direction	N/A
N/A	X Walk 1 Width (in)	N/A	N/A	X Walk 2 Width (in)	N/A
	X Walk 1 Slope (%)	6.7		X Walk 2 Slope (%)	N/A
	X Walk 1 X Slope (%)	1.7		X Walk 2 X Slope (%)	N/A

N/A	Ramp inside XWalk1?	N/A	N/A	Ramp inside XWalk2?	N/A
	Road Slope (%)	N/A	N/A	Clear Space?	Yes
	Road X Slope (%)	N/A	N/A	Clear Space to XWalk (in)	N/A
Yes	Any Obstructions?	No	Yes	Storm Grate/Utility Hazard?	No
	Obstruction Type			Storm Grate/Utility Type	
			N/A		N/A
			Yes	Surface Condition? (G/P)	Good

Possible Solutions:

**Remove & Replace Entire Ramp.
Remove & Replace Gutter.**

Total Cost: \$ 2600.00
