## Access Compliance Report Public Rights-of-Way (Curb Ramps)

Intersection ID: 30018 Main Street: W\_MALLARD\_CREEK\_CHURCIC\_RSDs Street: BERKELEY\_PLACE\_DR Location: NE

ADA ID: 56DA79925935 Ramp Type: Perp Initial Pass/Fail: Fail Overall Compliance: No Severity Score: 26.25

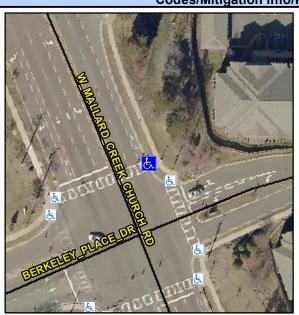
Field Measurements/Component Compliance						
Compli	iance Description	Data	Comp	liance Description	Data	
N/A	Ramp Length (in)	85.0	No	Ramp Slope (%)	12.1	
Yes	Ramp Width (in)	48.0	No	Ramp XSlope (%)	2.8	
N/A	Flare Type LT	N/A	N/A	Flare Type RT	N/A	
N/A	Flare Slope LT (%)	N/A	N/A	Flare Slope RT (%)	N/A	
N/A	Flare Traversable LT?	N/A	N/A	Flare Traversable RT?	N/A	
N/A	Landing Length (in)	N/A	N/A	DWS Provided?	N/A	
N/A	Landing Width (in)	N/A	N/A	DWS Contrast?	N/A	
N/A	Landing Slope (%)	N/A	N/A	DWS Length (in)	N/A	
N/A	Landing X Slope (%)	N/A	N/A	DWS Full Width?	N/A	
N/A	Landing Curb? (Y/N)	N/A	N/A	DWS Offset (in)	N/A	
N/A	Shared Landing?	N/A				
N/A	Gutter Ponding?	N/A	N/A	Gutter Slope (%)	N/A	
N/A	Gutter Lip Ht (in)	N/A	N/A	Gutter X Slope (%)	N/A	
N/A	Painted X Walk1?	Yes	N/A	Painted X Walk2?	N/A	
	X Walk 1 Direction	To W		X Walk 2 Direction	N/A	
N/A	X Walk 1 Width (in)	113.0	N/A	X Walk 2 Width (in)	N/A	
	X Walk 1 Slope (%)	4.1		X Walk 2 Slope (%)	N/A

X Walk 1 X Slope (%)	2.1		X Walk 2 X Slope (%)	N/A	
N/A	Ramp inside XWalk1?	Yes	N/A	Ramp inside XWalk2?	N/A	
	Road Slope (%)	N/A	N/A	Clear Space?	N/A	
	Road X Slope (%)	N/A	N/A	Clear Space to XWalk (in)	N/A	
N/A	Any Obstructions?	N/A	N/A	Storm Grate/Utility Hazard?	N/A	
	Obstruction Type			Storm Grate/Utility Type		
		N/A			N/A	
			Yes	Surface Condition? (G/P)	Good

Possible Solutions:	<u> </u>
Remove & Replace Entire Ramp.	N
	Y
	N
	N
	N
	N
Surveyor Notes:	N
N/A	N
	N
	N
	N
PROW/ADA:	N
R304.2.2, R304.5.3	N
	N
	N
