Access Compliance Report

Public Rights-of-Way

(Curb Ramps)

Intersection ID: 27288	Main Street: PIPER_STATION_DR	Cross Street: REA_RD	Location: NW
ADA ID: 56DC99344763	Ramp Type: PerpDiag	Initial Pass/Fail: Fail	Overall Compliance: No
Severity Score: 35			
Codes/Mitigation Info/Possible Solution		Field Measurements/Component Compliance

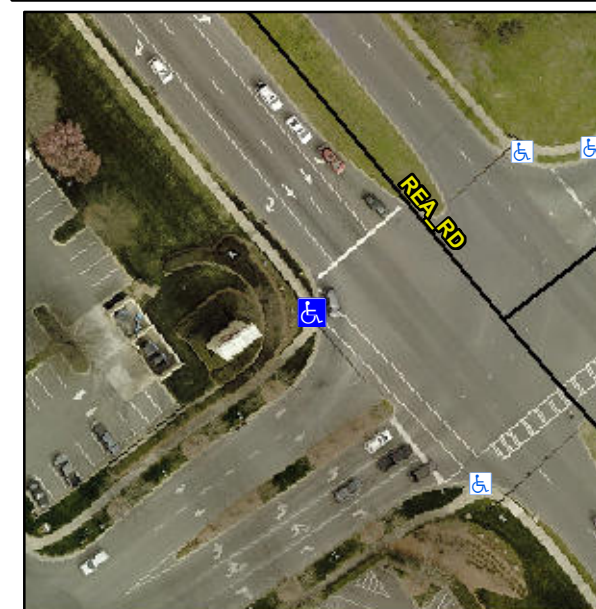
Not Found, R304.5.1, R304.2.2

Compliance	Description	Data	Compliance	Description	Data
N/A	Ramp Length (in)	68.0	No	Ramp Slope (%)	12.3
No	Ramp Width (in)	47.0	Yes	Ramp XSlope (%)	2.3
N/A	Flare Type LT	N/A	N/A	Flare Type RT	N/A
N/A	Flare Slope LT (%)	N/A	N/A	Flare Slope RT (%)	N/A
N/A	Flare Traversable LT?	N/A	N/A	Flare Traversable RT?	N/A
N/A	Landing Length (in)	N/A	N/A	DWS Provided?	N/A
N/A	Landing Width (in)	N/A	N/A	DWS Contrast?	N/A
N/A	Landing Slope (%)	N/A	N/A	DWS Length (in)	N/A
N/A	Landing X Slope (%)	N/A	N/A	DWS Full Width?	N/A
N/A	Landing Curb? (Y/N)	N/A	N/A	DWS Offset (in)	N/A
N/A	Shared Landing?	N/A			
N/A	Gutter Ponding?	N/A	N/A	Gutter Slope (%)	N/A
N/A	Gutter Lip Ht (in)	N/A	N/A	Gutter X Slope (%)	N/A
N/A	Painted X Walk1?	Yes	N/A	Painted X Walk2?	No
	X Walk 1 Direction	To SE		X Walk 2 Direction	To NE
N/A	X Walk 1 Width (in)	105.0	N/A	X Walk 2 Width (in)	N/A
	X Walk 1 Slope (%)	5.4		X Walk 2 Slope (%)	1.8
	X Walk 1 X Slope (%)	0.1		X Walk 2 X Slope (%)	4.9

N/A	Ramp inside XWalk1?	Yes	N/A	Ramp inside XWalk2?	N/A
	Road Slope (%)	3.4	N/A	Clear Space?	N/A
	Road X Slope (%)	2.5	N/A	Clear Space to XWalk (in)	N/A
N/A	Any Obstructions?	N/A	N/A	Storm Grate/Utility Hazard?	N/A
	Obstruction Type			Storm Grate/Utility Type	
		N/A			N/A
		Yes		Surface Condition? (G/P)	Good

Possible Solutions:

Remove & Replace Curb Ramp With Two New Directional Ramps or Equivalent.
