## Access Compliance Report Public Rights-of-Way (Curb Ramps)

Intersection ID: 10822 Main Street: PINCKNEY\_AV Cross Street: WOODSIDE\_AV Location: E

ADA ID: 56E5131EAB60 Ramp Type: Perp Initial Pass/Fail: Fail Overall Compliance: No Severity Score: 8.75

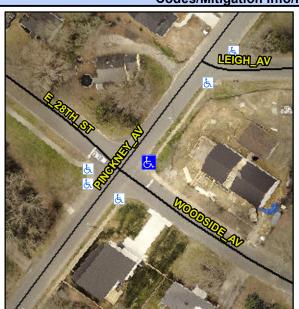
Field Measurements/Component Compliance								
Compliance Description		Data	Comp	oliance Description	Data			
	N/A	Ramp Length (in)	72.0	Yes	Ramp Slope (%)	6.5		
	No	Ramp Width (in)	36.0	Yes	Ramp XSlope (%)	1.0		
	N/A	Flare Type LT	N/A	N/A	Flare Type RT	N/A		
	N/A	Flare Slope LT (%)	N/A	N/A	Flare Slope RT (%)	N/A		
	N/A	Flare Traversable LT?	N/A	N/A	Flare Traversable RT?	N/A		
	N/A	Landing Length (in)	N/A	N/A	DWS Provided?	N/A		
	N/A	Landing Width (in)	N/A	N/A	DWS Contrast?	N/A		
	N/A	Landing Slope (%)	N/A	N/A	DWS Length (in)	N/A		
	N/A	Landing X Slope (%)	N/A	N/A	DWS Full Width?	N/A		
	N/A	Landing Curb? (Y/N)	N/A	N/A	DWS Offset (in)	N/A		
	N/A	Shared Landing?	N/A					
	N/A	Gutter Ponding?	N/A	N/A	Gutter Slope (%)	N/A		
	N/A	Gutter Lip Ht (in)	N/A	N/A	Gutter X Slope (%)	N/A		
	N/A	Painted X Walk1?	No	N/A	Painted X Walk2?	N/A		
		X Walk 1 Direction	To SW		X Walk 2 Direction	N/A		
	N/A	X Walk 1 Width (in)	N/A	N/A	X Walk 2 Width (in)	N/A

X Walk 1 Slope (%)	2.0		X Walk 2 Slope (%)	N/A		
		X Walk 1 X Slope (%)	2.8		X Walk 2 X Slope (%)	N/A		
	N/A	Ramp inside XWalk1?	N/A	N/A	Ramp inside XWalk2?	N/A		
		Road Slope (%)	N/A	N/A	Clear Space?	N/A		
		Road X Slope (%)	N/A	N/A	Clear Space to XWalk (in)	N/A		
	N/A	Any Obstructions?	N/A	N/A	Storm Grate/Utility Hazard?	N/A		
		Obstruction Type			Storm Grate/Utility Type			
			N/A			N/A		
				Yes	Surface Condition? (G/P)	Good		
8				-

Possible Solutions:						
Remove & Replace Entire Ramp.						
	1					
	'					
	i					
Surveyor Notes:	ı					
N/A	ı					
	ı					
	ı					
DDOW/ADA.						
PROW/ADA:						
Not Found, R304.5.1

Total Cost: \$ 1850.00
