# Access Compliance Report

## Public Rights-of-Way

### (Curb Ramps)

| Intersection ID: 46324 | Main Street: ARBOR_VISTA_DR | Cross Street: SENATOR_ROYALL_DR | Location: NW |

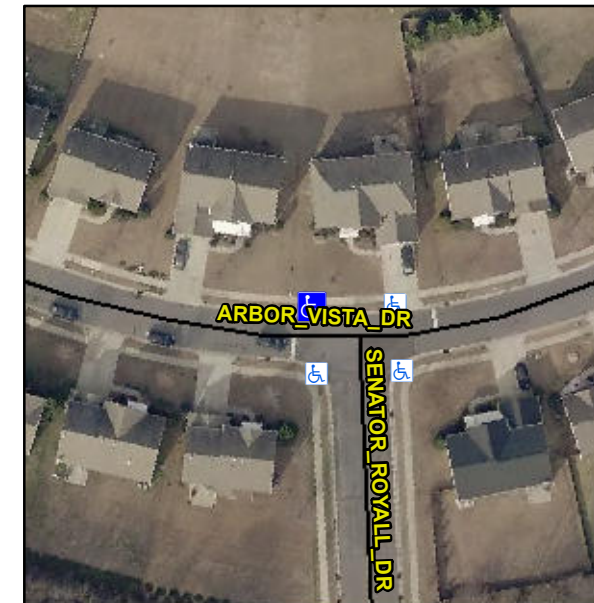
| ADA ID: 56F3E94FFDC6 | Ramp Type: Perp | Initial Pass/Fail: Pass | Overall Compliance: No |
| | | Severity Score: 22.5 | |

| Compliance | Description | Data | Compliance | Description | Data |
|---|---|---|---|---|---|
| Yes | Landing Length (in) | 49.0 | No | DWS Provided? | No |
| No | Landing Slope (%) | 3.3 | N/A | DWS Length (in) | N/A |
| Yes | Gutter Ponding? | No | No | Gutter Slope (%) | 5.7 |
| No | Gutter Lip Ht (in) | 0.5 | Yes | Gutter X Slope (%) | 0.1 |

Possible Solutions:

**Remove & Replace Entire Ramp.  
Remove & Replace Gutter.**

**R304.2.2-Perp, R304.3.2-Para, R305,  
R302.7.2, R304.5.4**

Total Cost: \$ 2600.00
