## **Access Compliance Report Public Rights-of-Way** (Curb Ramps)

Intersection ID: 14378 Main Street: E WORTHINGTON AV **Cross Street: EUCLID AV** Location: ADA ID: 56F7B2E36E40 Ramp Type: BlendTrans1 Initial Pass/Fail: Fail **Overall Compliance: No Severity Score:** 1.25

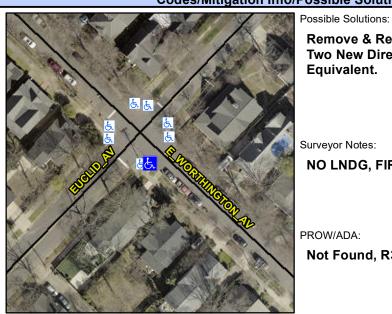
NO LNDG, FIRE HYDRANT LT FL

Not Found, R304.5.3

N/A	Ramp Length (in)	158.0	Yes	BlendTrans Slope (%)	1.6
Yes	Ramp Width (in)	48.0	No	BlendTrans XSlope (%)	2.7
N/A	Flare Type LT	N/A	N/A	Flare Type RT	N/A
N/A	Flare Slope LT (%)	N/A	N/A	Flare Slope RT (%)	N/A
N/A	Flare Traversable LT?	N/A	N/A	Flare Traversable RT?	N/A
N/A	Landing Length (in)	N/A	N/A	DWS Provided?	N/A
N/A	Landing Width (in)	N/A	N/A	DWS Contrast?	N/A
N/A	Landing Slope (%)	N/A	N/A	DWS Length (in)	N/A
N/A	Landing X Slope (%)	N/A	N/A	DWS Full Width?	N/A
N/A	Landing Curb? (Y/N)	N/A	N/A	DWS Offset (in)	N/A
N/A	Shared Landing?	N/A			
N/A	Gutter Ponding?	N/A	N/A	Gutter Slope (%)	N/A
N/A	Gutter Lip Ht (in)	N/A	N/A	Gutter X Slope (%)	N/A
N/A	Painted X Walk1?	No	N/A	Painted X Walk2?	N/A
	X Walk 1 Direction	To NE		X Walk 2 Direction	N/A
	X Walk 1 Width (in)	N/A		X Walk 2 Width (in)	N/A
	X Walk 1 Slope (%)	4.0		X Walk 2 Slope (%)	N/A
	X Walk 1 X Slope (%)	0.4		X Walk 2 X Slope (%)	N/A
N/A	Ramp inside XWalk1?	N/A	N/A	Ramp inside XWalk2?	N/A

Road Slope (%)	0.4		Clear Space?	N/A
	Road X Slope (%)	4.0	N/A	Clear Space to XWalk (in)	N/A
N/A	Any Obstructions?	N/A	N/A	Storm Grate/Utility Hazard?	N/A
	Obstruction Type		l	Storm Grate/Utility Type	
		N/A			N/A
			Yes	Surface Condition? (G/P)	Good

**E WORTHINGTON AV** Street 1 Name Stop Condition-Street 1 StopSign Street 2 Name N/A Stop Condition-Street 2 N/A Remove & Replace Curb Ramp With Two New Directional Ramps or Equivalent.

3200.00
