Access Compliance Report

Public Rights-of-Way

(Curb Ramps)

Intersection ID: N/A	Main Street: LITTLE ROCK RD	Cross Street: N/A	Location: NE
ADA ID: 56F815EB72E6	Ramp Type: Directional2	Initial Pass/Fail: Fail	Overall Compliance: No
Codes/Mitigation Info/Possible Solution		Field Measurements/Component Compliance	
Severity Score: 21.25

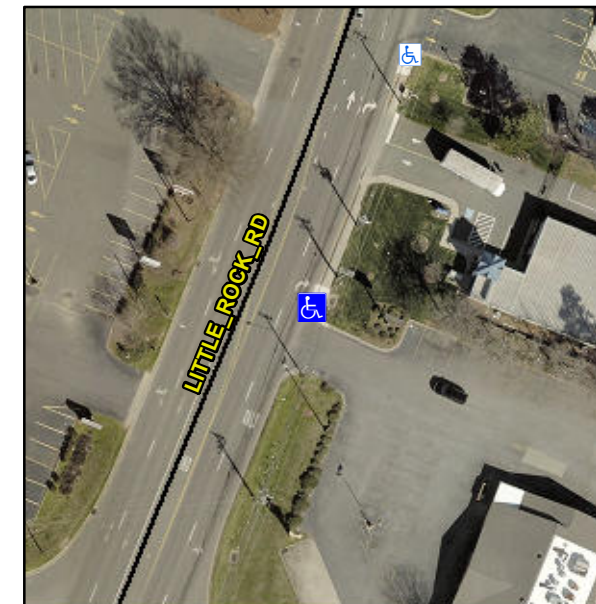
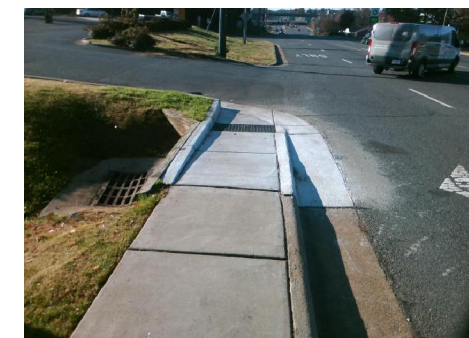
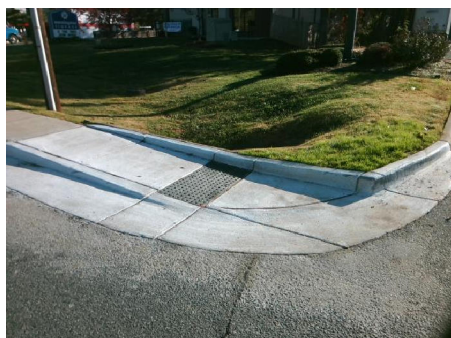
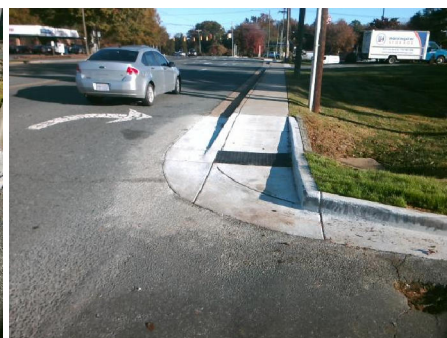
R304.5.1, R304.2.2

Compliance	Description	Data	Compliance	Description	Data
N/A	Ramp Length (in)	132.0	N/A	Grade Break?	N/A
No	Ramp Width (in)	46.5	N/A	Grade Break Slope (%)	0.0
No	Ramp Slope (%)	9.6	N/A	Grade Break XSlope (%)	0.0
Yes	Ramp XSlope (%)	0.5			
N/A	Flare Type LT	N/A	N/A	Flare Type RT	N/A
N/A	Flare Slope LT (%)	N/A	N/A	Flare Slope RT (%)	0.0
N/A	Flare Traversable LT?	No	N/A	Flare Traversable RT?	No
N/A	Landing Length (in)	0.0	N/A	DWS Provided?	N/A
N/A	Landing Width (in)	0.0	N/A	DWS Contrast?	N/A
N/A	Landing Slope (%)	0.0	N/A	DWS Length (in)	N/A
N/A	Landing X Slope (%)	0.0	N/A	DWS Full Width?	N/A
N/A	Landing Curb? (Y/N)	N/A	N/A	DWS Offset LT (in)	N/A
N/A	Shared Landing?	N/A	N/A	DWS Offset RT (in)	N/A
N/A	Gutter Ponding?	0.0	N/A	Gutter Slope (%)	N/A
N/A	Gutter Lip Ht (in)	0.0	N/A	Gutter X Slope (%)	N/A
N/A	Painted X Walk1?	No		Road Slope (%)	1.8
	X Walk 1 Direction	To S		Road X Slope (%)	5.9
	X Walk 1 Width (in)	N/A		Clear Space?	N/A

X Walk 1 Slope (%)	1.8	N/A	Clear Space to XWalk (in)	N/A
	X Walk 1 X Slope (%)	5.9	N/A	Storm Grate/Utility Hazard?	N/A
N/A	Ramp inside XWalk1?	N/A		Storm Grate/Utility Type	
N/A	Any Obstructions?	N/A			N/A
	Obstruction Type		Yes	Surface Condition? (G/P)	Good
			N/A	Curb Slope (%)	5.1

Remove & Replace Entire Ramp.
