Access Compliance Report

Public Rights-of-Way

(Curb Ramps)

Intersection ID: 3612	Main Street: BRIDLE_RIDGE_LN	Cross Street: FURLONG_TL	Location: NE
ADA ID: 57095A29CA24	Ramp Type: Perp	Initial Pass/Fail: Fail	Overall Compliance: No
Severity Score: 8.75			
Codes/Mitigation Info/Possible Solution		Field Measurements/Component Compliance

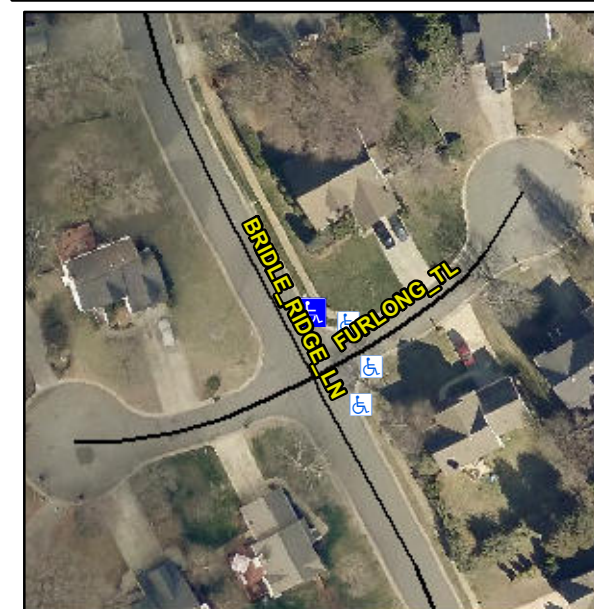
Not Found, R304.5.1

Compliance	Description	Data	Compliance	Description	Data
N/A	Ramp Length (in)	51.0	Yes	Ramp Slope (%)	5.0
No	Ramp Width (in)	47.5	Yes	Ramp XSlope (%)	0.8
N/A	Flare Type LT	N/A	N/A	Flare Type RT	N/A
N/A	Flare Slope LT (%)	N/A	N/A	Flare Slope RT (%)	N/A
N/A	Flare Traversable LT?	N/A	N/A	Flare Traversable RT?	N/A
N/A	Landing Length (in)	N/A	N/A	DWS Provided?	N/A
N/A	Landing Width (in)	N/A	N/A	DWS Contrast?	N/A
N/A	Landing Slope (%)	N/A	N/A	DWS Length (in)	N/A
N/A	Landing X Slope (%)	N/A	N/A	DWS Full Width?	N/A
N/A	Landing Curb? (Y/N)	N/A	N/A	DWS Offset (in)	N/A
N/A	Shared Landing?	N/A			
N/A	Gutter Ponding?	N/A	N/A	Gutter Slope (%)	N/A
N/A	Gutter Lip Ht (in)	N/A	N/A	Gutter X Slope (%)	N/A
N/A	Painted X Walk1?	No	N/A	Painted X Walk2?	N/A
	X Walk 1 Direction	To W		X Walk 2 Direction	N/A
N/A	X Walk 1 Width (in)	N/A	N/A	X Walk 2 Width (in)	N/A
	X Walk 1 Slope (%)	4.0		X Walk 2 Slope (%)	N/A
	X Walk 1 X Slope (%)	0.7		X Walk 2 X Slope (%)	N/A

N/A	Ramp inside XWalk1?	N/A	N/A	Ramp inside XWalk2?	N/A
	Road Slope (%)	N/A	N/A	Clear Space?	N/A
	Road X Slope (%)	N/A	N/A	Clear Space to XWalk (in)	N/A
N/A	Any Obstructions?	N/A	N/A	Storm Grate/Utility Hazard?	N/A
	Obstruction Type			Storm Grate/Utility Type	
		N/A			N/A
			Yes	Surface Condition? (G/P)	Good

Remove & Replace Entire Ramp.

Total Cost: \$ 1850.00
