# Access Compliance Report

## Public Rights-of-Way

### (Curb Ramps)

Intersection ID: 16516	Main Street: IDLEBROOK_DR	Cross Street: MEADOWDALE_LN	Location: NW
ADA ID: 570BC9C47BAB	Ramp Type: BlendTrans2	Initial Pass/Fail: Fail	Overall Compliance: No
Severity Score: 10			
Codes/Mitigation Info/Possible Solution		Field Measurements/Component Compliance

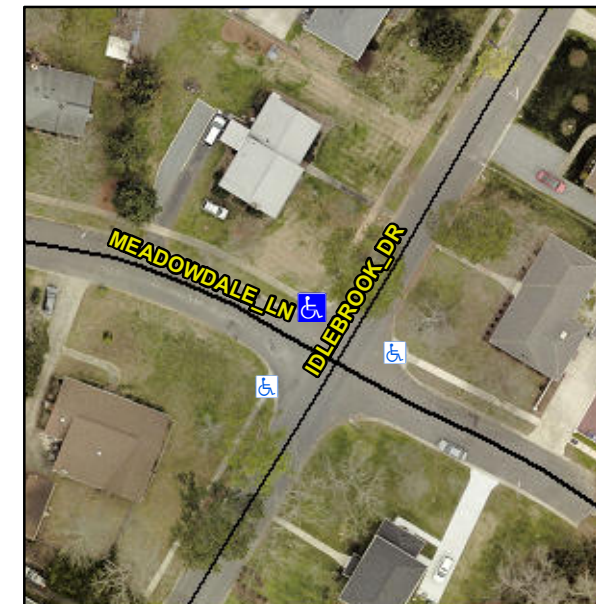
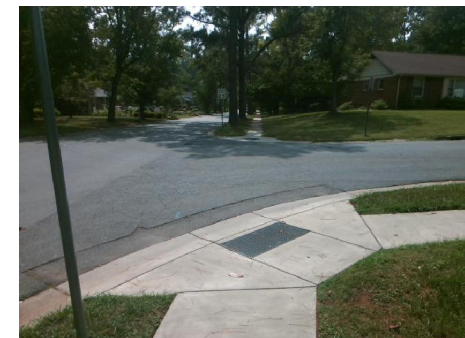
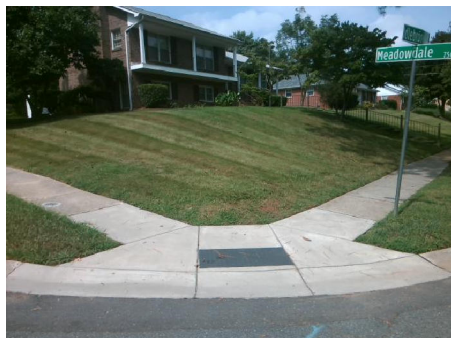
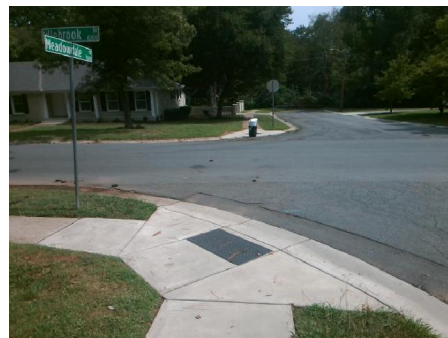
**Not Found, R304.5.1, R304.5.3**

Compliance	Description	Data	Compliance	Description	Data
N/A	Ramp Length (in)	68.0	Yes	BlendTrans Slope (%)	2.8
No	Ramp Width (in)	46.0	No	BlendTrans XSlope (%)	4.2
N/A	Flare Type LT	N/A	N/A	Flare Type RT	N/A
N/A	Flare Slope LT (%)	N/A	N/A	Flare Slope RT (%)	N/A
N/A	Flare Traversable LT?	N/A	N/A	Flare Traversable RT?	N/A
N/A	Landing Length (in)	N/A	N/A	DWS Provided?	N/A
N/A	Landing Width (in)	N/A	N/A	DWS Contrast?	N/A
N/A	Landing Slope (%)	N/A	N/A	DWS Length (in)	N/A
N/A	Landing X Slope (%)	N/A	N/A	DWS Full Width?	N/A
N/A	Landing Curb? (Y/N)	N/A	N/A	DWS Offset (in)	N/A
N/A	Shared Landing?	N/A			
N/A	Gutter Ponding?	N/A	N/A	Gutter Slope (%)	N/A
N/A	Gutter Lip Ht (in)	N/A	N/A	Gutter X Slope (%)	N/A
N/A	Painted X Walk1?	No	N/A	Painted X Walk2?	No
	X Walk 1 Direction	To SW		X Walk 2 Direction	To SE
	X Walk 1 Width (in)	N/A		X Walk 2 Width (in)	N/A
	X Walk 1 Slope (%)	0.4		X Walk 2 Slope (%)	0.3
	X Walk 1 X Slope (%)	2.6		X Walk 2 X Slope (%)	2.0

N/A	Ramp inside XWalk1?	N/A	N/A	Ramp inside XWalk2?	N/A
	Road Slope (%)	2.7		Clear Space?	N/A
	Road X Slope (%)	0.3	N/A	Clear Space to XWalk (in)	N/A
N/A	Any Obstructions?	N/A	N/A	Storm Grate/Utility Hazard?	N/A
	Obstruction Type			Storm Grate/Utility Type	
		N/A			N/A
			Yes	Surface Condition? (G/P)	Good
			No	Curb Slope (%)	13.0

**Remove & Replace Curb Ramp With Two New Directional Ramps or Equivalent.**
