# Access Compliance Report

## Public Rights-of-Way

### (Curb Ramps)

Intersection ID: 44810	Main Street: NEVIN_RD	Cross Street: VICTORY_LN	Location: SW
ADA ID: 5714FA87C746	Ramp Type: PerpDiag	Initial Pass/Fail: Fail	Overall Compliance: No
Codes/Mitigation Info/Possible Solution		Field Measurements/Component Compliance	
		Severity Score: 10

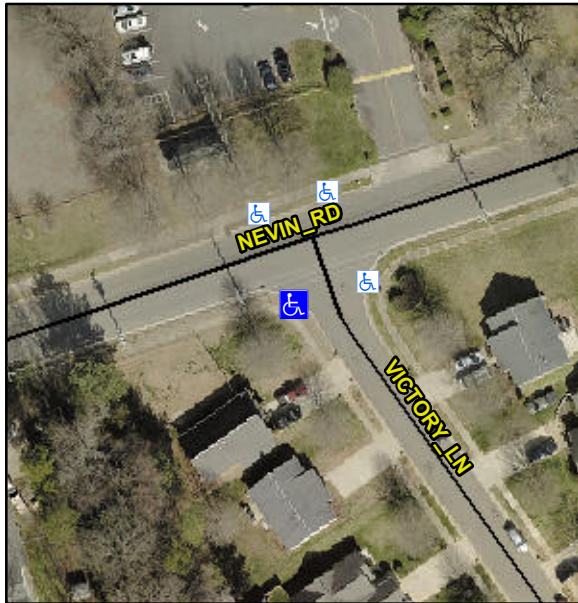
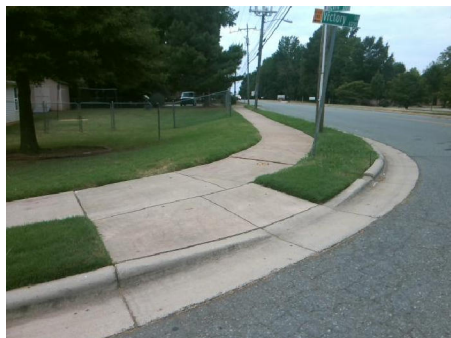
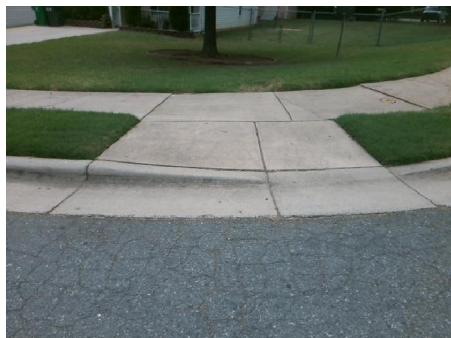
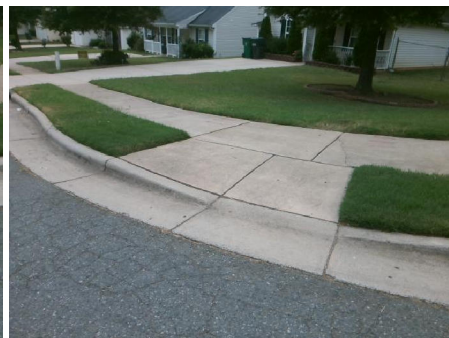
**R304.5.1, R304.5.3**

Compliance	Description	Data	Compliance	Description	Data
N/A	Ramp Length (in)	48.0	Yes	Ramp Slope (%)	8.2
No	Ramp Width (in)	39.0	No	Ramp XSlope (%)	3.3
N/A	Flare Type LT	N/A	N/A	Flare Type RT	N/A
N/A	Flare Slope LT (%)	N/A	N/A	Flare Slope RT (%)	N/A
N/A	Flare Traversable LT?	N/A	N/A	Flare Traversable RT?	N/A
N/A	Landing Length (in)	N/A	N/A	DWS Provided?	N/A
N/A	Landing Width (in)	N/A	N/A	DWS Contrast?	N/A
N/A	Landing Slope (%)	N/A	N/A	DWS Length (in)	N/A
N/A	Landing X Slope (%)	N/A	N/A	DWS Full Width?	N/A
N/A	Landing Curb? (Y/N)	N/A	N/A	DWS Offset (in)	N/A
N/A	Shared Landing?	N/A			
N/A	Gutter Ponding?	N/A	N/A	Gutter Slope (%)	N/A
N/A	Gutter Lip Ht (in)	N/A	N/A	Gutter X Slope (%)	N/A
N/A	Painted X Walk1?	No	N/A	Painted X Walk2?	No
	X Walk 1 Direction	To E		X Walk 2 Direction	To N
N/A	X Walk 1 Width (in)	N/A	N/A	X Walk 2 Width (in)	N/A
	X Walk 1 Slope (%)	1.5		X Walk 2 Slope (%)	3.3
	X Walk 1 X Slope (%)	4.9		X Walk 2 X Slope (%)	1.3

N/A	Ramp inside XWalk1?	N/A	N/A	Ramp inside XWalk2?	N/A
	Road Slope (%)	4.1	N/A	Clear Space?	N/A
	Road X Slope (%)	2.3	N/A	Clear Space to XWalk (in)	N/A
N/A	Any Obstructions?	N/A	N/A	Storm Grate/Utility Hazard?	N/A
	Obstruction Type			Storm Grate/Utility Type	
		N/A			N/A
			Yes	Surface Condition? (G/P)	Good

**Remove & Replace Curb Ramp With Two New Directional Ramps or Equivalent.**
