Access Compliance Report

Public Rights-of-Way

(Curb Ramps)

Intersection ID: 30572	Main Street: ARBOR_TREE_LN	Cross Street: HAMILTON_GREEN_DR	Location: NW
ADA ID: 5719147D6A67	Ramp Type: BlendTrans1	Initial Pass/Fail: Fail	Overall Compliance: No
		Severity Score: 12.5

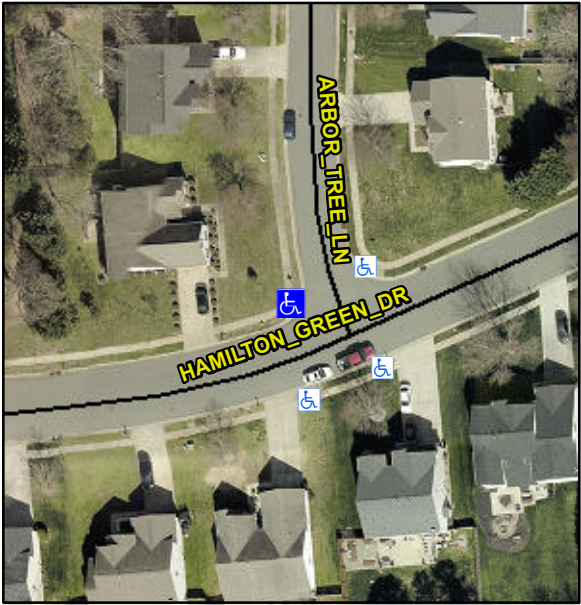
Possible Solutions:		Compliance	Description	Data	
	Remove & Replace Curb Ramp With Two New Directional Ramps or Equivalent.		N/A	Ramp Length (in)	52.0	Yes
			Yes	Ramp Width (in)	48.0	No
			N/A	Flare Type LT	N/A	N/A
			N/A	Flare Slope LT (%)	N/A	N/A
			N/A	Flare Traversable LT?	N/A	N/A
			N/A	Landing Length (in)	N/A	N/A
			N/A	Landing Width (in)	N/A	N/A
			N/A	Landing Slope (%)	N/A	N/A
			N/A	Landing X Slope (%)	N/A	N/A
<p>Surveyor Notes:</p> <p>N/A</p> <p>PROW/ADA:</p> <p>R304.5.3</p>			N/A	Flare Type RT	N/A	N/A
			N/A	Flare Slope RT (%)	N/A	N/A
			N/A	Flare Traversable RT?	N/A	N/A
			N/A	DWS Provided?	N/A	N/A
			N/A	DWS Contrast?	N/A	N/A
			N/A	DWS Length (in)	N/A	N/A
			N/A	DWS Full Width?	N/A	N/A
			N/A	DWS Offset (in)	N/A	N/A
			N/A	Gutter Ponding?	N/A	N/A
			N/A	Gutter Lip Ht (in)	N/A	N/A
<p>Total Cost:</p> <p>\$ 3200.00</p>			N/A	Painted X Walk1?	No	N/A

X Walk 1 Direction	To S	
				X Walk 1 Width (in)	N/A	
				X Walk 1 Slope (%)	4.3	
				X Walk 1 X Slope (%)	5.3	
			N/A	Ramp inside XWalk1?	N/A	N/A
				Road Slope (%)	3.8	
				Road X Slope (%)	5.1	N/A
			N/A	Any Obstructions?	N/A	N/A
				Obstruction Type		
					N/A	N/A
					Yes	Surface Condition? (G/P)
					N/A	Curb Slope (%)
						Good
