Access Compliance Report

Public Rights-of-Way

(Curb Ramps)

Intersection ID: N/A	Main Street: MARKLAND_DR	Cross Street: WEDGEFIELD_DR	Location: NE
ADA ID: 572144876094	Ramp Type: PerpDiag	Initial Pass/Fail: Fail	Overall Compliance: No
		Severity Score: 37.5

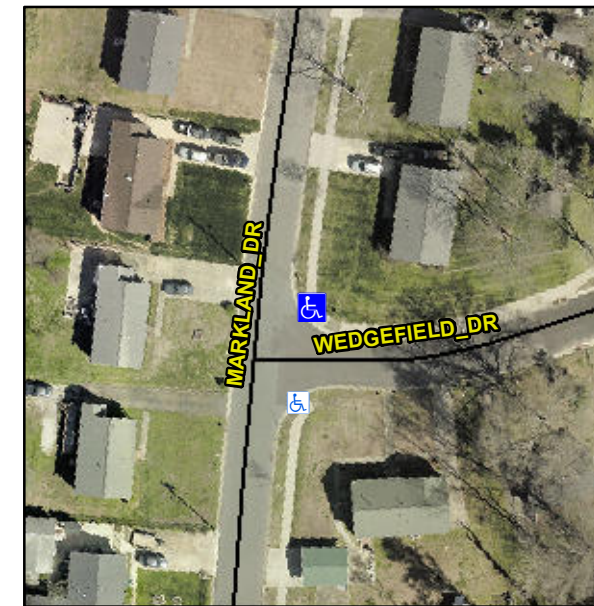
Not Found, R304.2.2, R304.5.3

Compliance	Description	Data	Compliance	Description	Data
N/A	Ramp Length (in)	86.0	No	Ramp Slope (%)	8.8
Yes	Ramp Width (in)	48.0	No	Ramp XSlope (%)	7.6
N/A	Flare Type LT	N/A	N/A	Flare Type RT	N/A
N/A	Flare Slope LT (%)	N/A	N/A	Flare Slope RT (%)	N/A
N/A	Flare Traversable LT?	N/A	N/A	Flare Traversable RT?	N/A
N/A	Landing Length (in)	N/A	N/A	DWS Provided?	N/A
N/A	Landing Width (in)	N/A	N/A	DWS Contrast?	N/A
N/A	Landing Slope (%)	N/A	N/A	DWS Length (in)	N/A
N/A	Landing X Slope (%)	N/A	N/A	DWS Full Width?	N/A
N/A	Landing Curb? (Y/N)	N/A	N/A	DWS Offset (in)	N/A
N/A	Shared Landing?	N/A			
N/A	Gutter Ponding?	N/A	N/A	Gutter Slope (%)	N/A
N/A	Gutter Lip Ht (in)	N/A	N/A	Gutter X Slope (%)	N/A
N/A	Painted X Walk1?	No	N/A	Painted X Walk2?	No
	X Walk 1 Direction	To W		X Walk 2 Direction	To S
N/A	X Walk 1 Width (in)	N/A	N/A	X Walk 2 Width (in)	N/A
	X Walk 1 Slope (%)	1.2		X Walk 2 Slope (%)	4.2
	X Walk 1 X Slope (%)	7.9		X Walk 2 X Slope (%)	3.2

N/A	Ramp inside XWalk1?	N/A	N/A	Ramp inside XWalk2?	N/A
	Road Slope (%)	7.3	N/A	Clear Space?	N/A
	Road X Slope (%)	0.9	N/A	Clear Space to XWalk (in)	N/A
N/A	Any Obstructions?	N/A	N/A	Storm Grate/Utility Hazard?	N/A
	Obstruction Type			Storm Grate/Utility Type	
		N/A			N/A
			Yes	Surface Condition? (G/P)	Good

Remove & Replace Curb Ramp With Two New Directional Ramps or Equivalent.

Total Cost: \$ 3200.00
