Good

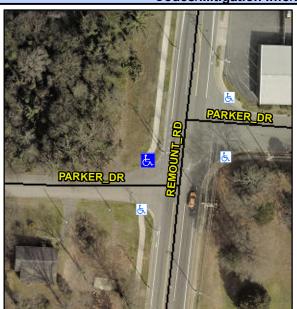
Intersection ID: N/A Main Street: REMOUNT RD Cross Street: PARKER DR Location: NW **Overall Compliance: No** ADA ID: 5722C9190C5F Ramp Type: Directional1 Initial Pass/Fail: Fail **Severity Score:** 1.25

Possible Solutions:	Compl	iance Description
Remove & Replace Entire Ramp.	N/A	Ramp Length (in)
	Yes	Ramp Width (in)
	Yes	Ramp Slope (%)
	No	Ramp XSlope (%)
	N/A	Flare Type LT
	N/A	Flare Slope LT (%)
Surveyor Notes:	N/A	Flare Traversable LT
N/A	N/A	Landing Length (in)
	N/A	Landing Width (in)
	N/A	Landing Slope (%)
	N/A	Landing X Slope (%
PROW/ADA:	N/A	Landing Curb? (Y/N
R304.5.3	N/A	Shared Landing?
	N/A	Gutter Ponding?
	N/A	Gutter Lip Ht (in)
	N/A	Painted X Walk1?
		X Walk 1 Direction
		X Walk 1 Width (in)
		X Walk 1 Slope (%)
		X Walk 1 X Slope (%
