Access Compliance Report Public Rights-of-Way (Curb Ramps)

Intersection ID: 45731 Main Street: REDWOOD_VALLEY_LN Cross Street: PROVENCE_LN Location: SE

ADA ID: 574168BA527A Ramp Type: PerpDiag Initial Pass/Fail: Fail Overall Compliance: No Severity Score: 12.5

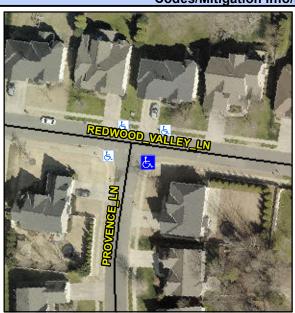
Not Found, R304.5.3

Field Measurements/Component Compliance						
Compliance Description		Data	Compli	ance	Description	Data
N/A	Ramp Length (in)	47.0	Yes	Ramp	Slope (%)	6.7
Yes	Ramp Width (in)	48.0	No	Ramp	XSlope (%)	6.3
N/A	Flare Type LT	N/A	N/A	Flare	Type RT	N/A
N/A	Flare Slope LT (%)	N/A	N/A	Flare	Slope RT (%)	N/A
N/A	Flare Traversable LT?	N/A	N/A	Flare	Traversable RT?	N/A
N/A	Landing Length (in)	N/A	N/A	DWS	Provided?	N/A
N/A	Landing Width (in)	N/A	N/A	DWS	Contrast?	N/A
N/A	Landing Slope (%)	N/A	N/A	DWS	Length (in)	N/A
N/A	Landing X Slope (%)	N/A	N/A	DWS	Full Width?	N/A
N/A	Landing Curb? (Y/N)	N/A	N/A	DWS	Offset (in)	N/A
N/A	Shared Landing?	N/A				
N/A	Gutter Ponding?	N/A	N/A	Gutte	r Slope (%)	N/A
N/A	Gutter Lip Ht (in)	N/A	N/A	Gutte	r X Slope (%)	N/A
N/A	Painted X Walk1?	No	N/A	Paint	ed X Walk2?	No
	X Walk 1 Direction	To NE		X Wa	lk 2 Direction	To NW
N/A	X Walk 1 Width (in)	N/A	N/A	X Wa	lk 2 Width (in)	N/A
	X Walk 1 Slope (%)	1.6		X Wa	lk 2 Slope (%)	3.6

X Walk 1 X Slope (%)	6.6		X Wa	lk 2 X Slope (%)	1.5
N/A	Ramp inside XWalk1?	N/A	N/A	Ram	inside XWalk2?	N/A
	Road Slope (%)	4.3	N/A	Clear	Space?	N/A
	Road X Slope (%)	3.4	N/A	Clear	Space to XWalk (in)	N/A
N/A	Any Obstructions?	N/A	N/A	Storn	Grate/Utility Hazard?	N/A
	Obstruction Type		l	Storn	n Grate/Utility Type	
		N/A	l			N/A
			I

Remove & Replace Curb Ramp With
Two New Directional Ramps or
Equivalent.

Total Cost: \$ 3200.00
