Access Compliance Report Public Rights-of-Way (Curb Ramps)

Intersection ID: 43098Main Street:HOPEDALE_AVCross Street:QUEENS_RD_WESTLocation:NWADA ID: 574367B7E866Ramp Type:Directional1Initial Pass/Fail:FailOverall Compliance:NoSeverity Score:37.5

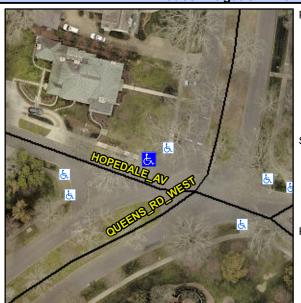
PROW/ADA:
R304.2.2, R304.5.3

Field Measurements/Component Compliance					
Comp	liance Description	Data	Comp	liance Description	Data
N/A	Ramp Length (in)	122.0	N/A	Grade Break?	N/A
Yes	Ramp Width (in)	53.0	N/A	Grade Break Slope (%)	0.0
No	Ramp Slope (%)	10.4	N/A	Grade Break XSlope (%)	0.0
No	Ramp XSlope (%)	7.9			
N/A	Flare Type LT	N/A	N/A	Flare Type RT	N/A
N/A	Flare Slope LT (%)	N/A	N/A	Flare Slope RT (%)	0.0
N/A	Flare Traversable LT?	N/A	N/A	Flare Traversable RT?	N/A
N/A	Landing Length (in)	0.0	N/A	DWS Provided?	N/A
N/A	Landing Width (in)	0.0	N/A	DWS Contrast?	N/A
N/A	Landing Slope (%)	0.0	N/A	DWS Length (in)	N/A
N/A	Landing X Slope (%)	0.0	N/A	DWS Full Width?	N/A
N/A	Landing Curb? (Y/N)	N/A	N/A	DWS Offset LT (in)	N/A
N/A	Shared Landing?	N/A	N/A	DWS Offset RT (in)	N/A
N/A	Gutter Ponding?	0.0	N/A	Gutter Slope (%)	N/A
N/A	Gutter Lip Ht (in)	0.0	N/A	Gutter X Slope (%)	N/A
N/A	Painted X Walk1?	No		Road Slope (%)	3.8
	X Walk 1 Direction	То Е		Road X Slope (%)	2.2

X Walk 1 Width (in)	N/A	l	Clear Space?	N/A
	X Walk 1 Slope (%)	3.8	N/A	Clear Space to XWalk (in)	N/A
	X Walk 1 X Slope (%)	2.2	N/A	Storm Grate/Utility Hazard?	N/A
N/A	Ramp inside XWalk1?	N/A		Storm Grate/Utility Type	
N/A	Any Obstructions?	N/A			N/A
	Obstruction Type		Yes	Surface Condition? (G/P)	Good
		N/A	N/A	Curb Slope (%)	18.5

Possible Solutions:

Remove & Replace Entire Ramp.
