# Access Compliance Report

## Public Rights-of-Way

### (Curb Ramps)

Intersection ID: 21772	Main Street: DOVERSHIRE_RD	Cross Street: SARDIS_RD	Location: SW
ADA ID: 5744FF7BEC88	Ramp Type: PerpDiag	Initial Pass/Fail: Fail	Overall Compliance: No
Severity Score: 22.5			
Codes/Mitigation Info/Possible Solution		Field Measurements/Component Compliance

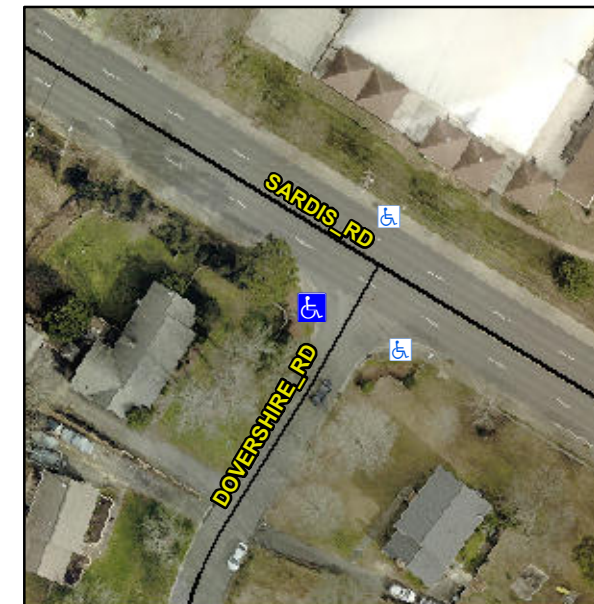
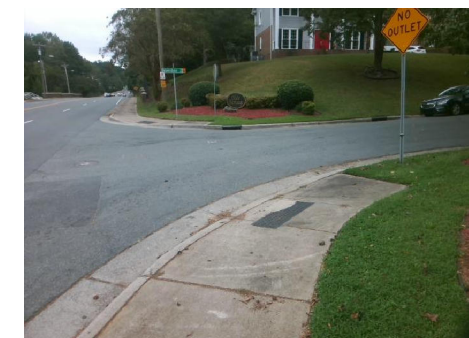
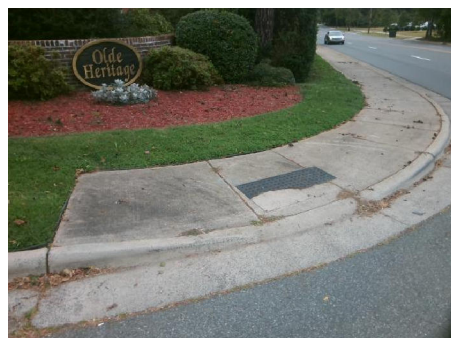
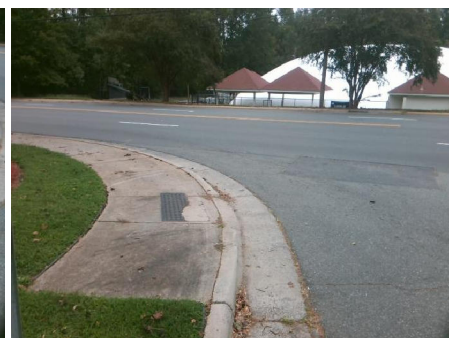
**Not Found, R304.5.1, R304.2.2, R304.5.3**

Compliance	Description	Data	Compliance	Description	Data
N/A	Ramp Length (in)	59.0	No	Ramp Slope (%)	8.7
No	Ramp Width (in)	39.0	No	Ramp XSlope (%)	2.1
N/A	Flare Type LT	N/A	N/A	Flare Type RT	N/A
N/A	Flare Slope LT (%)	N/A	N/A	Flare Slope RT (%)	N/A
N/A	Flare Traversable LT?	N/A	N/A	Flare Traversable RT?	N/A
N/A	Landing Length (in)	N/A	N/A	DWS Provided?	N/A
N/A	Landing Width (in)	N/A	N/A	DWS Contrast?	N/A
N/A	Landing Slope (%)	N/A	N/A	DWS Length (in)	N/A
N/A	Landing X Slope (%)	N/A	N/A	DWS Full Width?	N/A
N/A	Landing Curb? (Y/N)	N/A	N/A	DWS Offset (in)	N/A
N/A	Shared Landing?	N/A			
N/A	Gutter Ponding?	N/A	N/A	Gutter Slope (%)	N/A
N/A	Gutter Lip Ht (in)	N/A	N/A	Gutter X Slope (%)	N/A
N/A	Painted X Walk1?	No	N/A	Painted X Walk2?	No
	X Walk 1 Direction	To SE		X Walk 2 Direction	To NE
N/A	X Walk 1 Width (in)	N/A	N/A	X Walk 2 Width (in)	N/A
	X Walk 1 Slope (%)	3.6		X Walk 2 Slope (%)	3.4
	X Walk 1 X Slope (%)	2.0		X Walk 2 X Slope (%)	2.8

N/A	Ramp inside XWalk1?	N/A	N/A	Ramp inside XWalk2?	N/A
	Road Slope (%)	2.9	N/A	Clear Space?	N/A
	Road X Slope (%)	2.7	N/A	Clear Space to XWalk (in)	N/A
N/A	Any Obstructions?	N/A	N/A	Storm Grate/Utility Hazard?	N/A
	Obstruction Type			Storm Grate/Utility Type	
		N/A			N/A
			Yes	Surface Condition? (G/P)	Good

**Remove & Replace Curb Ramp With Two New Directional Ramps or Equivalent.**

Total Cost: \$ 3200.00
