Access Compliance Report

Public Rights-of-Way

(Curb Ramps)

Intersection ID: 9123	Main Street: ROZZELLES_FERRY_RD	Cross Street: CORONET_WY	Location: S
ADA ID: 575E09124856	Ramp Type: Perp	Initial Pass/Fail: Fail	Overall Compliance: No
Severity Score: 22.5			
Codes/Mitigation Info/Possible Solution		Field Measurements/Component Compliance

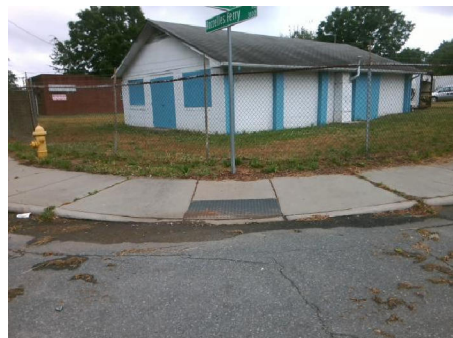
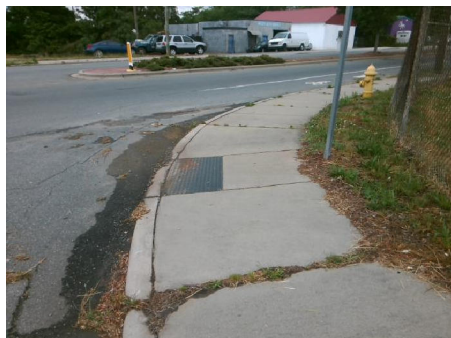
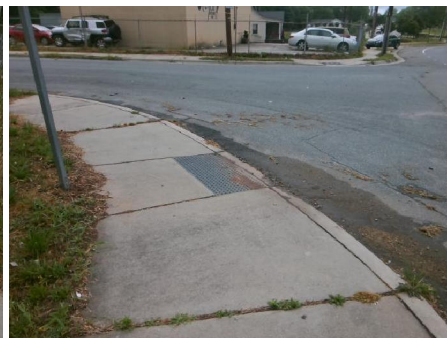
Not Found, R304.5.1, R304.2.2, R304.5.3

Compliance	Description	Data	Compliance	Description	Data
N/A	Ramp Length (in)	70.0	No	Ramp Slope (%)	8.5
No	Ramp Width (in)	47.5	No	Ramp XSlope (%)	2.1
N/A	Flare Type LT	N/A	N/A	Flare Type RT	N/A
N/A	Flare Slope LT (%)	N/A	N/A	Flare Slope RT (%)	N/A
N/A	Flare Traversable LT?	N/A	N/A	Flare Traversable RT?	N/A
N/A	Landing Length (in)	N/A	N/A	DWS Provided?	N/A
N/A	Landing Width (in)	N/A	N/A	DWS Contrast?	N/A
N/A	Landing Slope (%)	N/A	N/A	DWS Length (in)	N/A
N/A	Landing X Slope (%)	N/A	N/A	DWS Full Width?	N/A
N/A	Landing Curb? (Y/N)	N/A	N/A	DWS Offset (in)	N/A
N/A	Shared Landing?	N/A			
N/A	Gutter Ponding?	Yes	N/A	Gutter Slope (%)	N/A
N/A	Gutter Lip Ht (in)	N/A	N/A	Gutter X Slope (%)	N/A
N/A	Painted X Walk1?	No	N/A	Painted X Walk2?	N/A
	X Walk 1 Direction	To NW		X Walk 2 Direction	N/A
N/A	X Walk 1 Width (in)	N/A	N/A	X Walk 2 Width (in)	N/A
	X Walk 1 Slope (%)	2.2		X Walk 2 Slope (%)	N/A
	X Walk 1 X Slope (%)	2.8		X Walk 2 X Slope (%)	N/A

N/A	Ramp inside XWalk1?	N/A	N/A	Ramp inside XWalk2?	N/A
	Road Slope (%)	N/A	N/A	Clear Space?	N/A
	Road X Slope (%)	N/A	N/A	Clear Space to XWalk (in)	N/A
N/A	Any Obstructions?	N/A	N/A	Storm Grate/Utility Hazard?	N/A
	Obstruction Type			Storm Grate/Utility Type	
		N/A			N/A
			Yes	Surface Condition? (G/P)	Good

Remove & Replace Entire Ramp.
